ASSESSMENT REPORT			
<b>Unique Document ID and Revision No:</b>	ONR-OFD-AR-19-016 Revision 0	<b>TRIM Ref:</b>	2019/142779
<b>Project:</b>	Hinkley Point B Reactor 3 Periodic Shutdown		
<b>Site:</b>	Hinkley Point B		
<b>Title:</b>	Assessment of EC 365309 Hinkley Point B Reactor 3 2019 Graphite Core Inspection Results and Justification for Return to Service		
<b>Nuclear Site Licence No:</b>	62C		
<b>Licence Condition(s):</b>	LC 30		
<b>ONR Assessment Rating (Mandatory):</b> <i>(Rating should be based on licensee's original safety case submission)</i>	Green		
<b>COIN Service Order:</b>	SVC4285368

**Hinkley Point B Reactor 3 Periodic Shutdown 2019 – Graphite Structural Integrity  
Assessment**

Assessment Report ONR-OFD-AR-19-016  
Revision 0  
23 May 2019

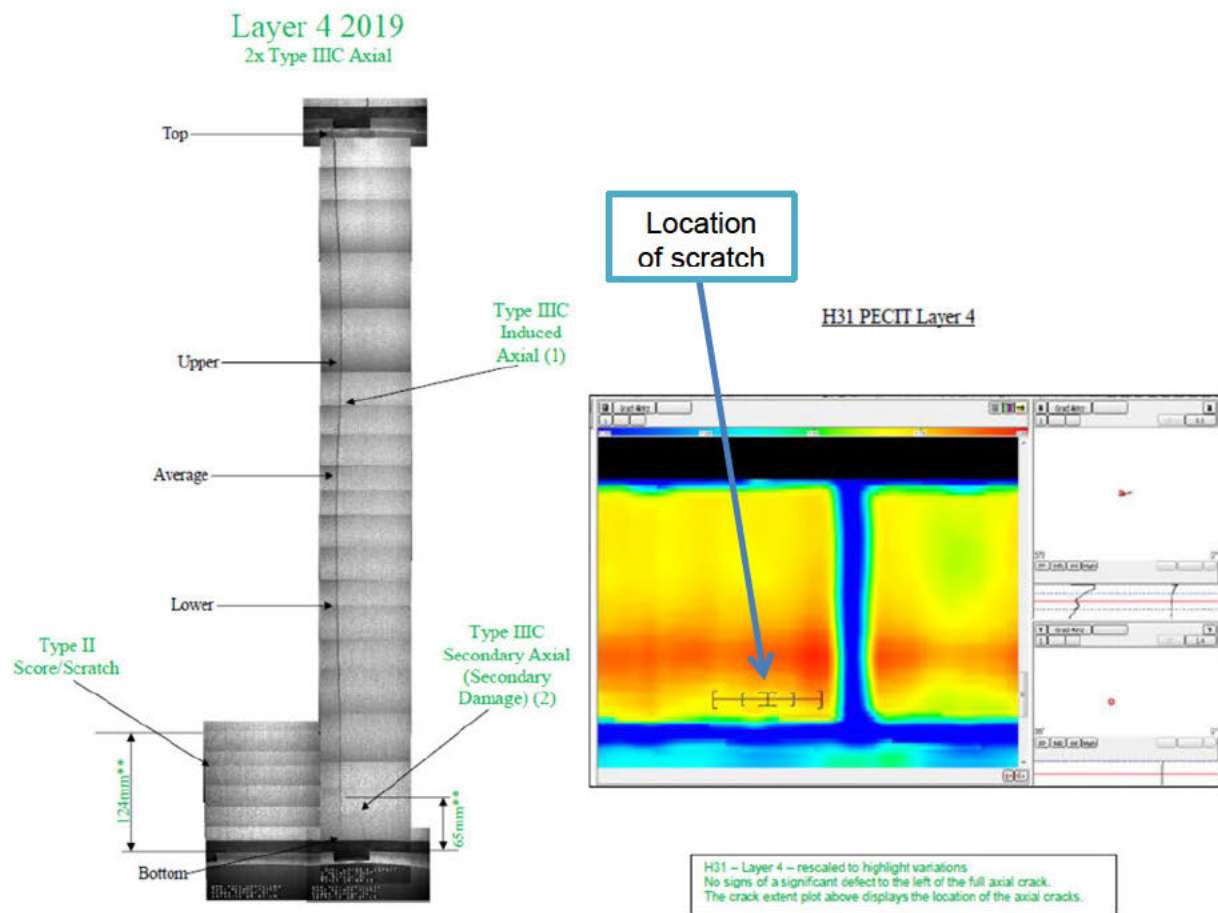
Figure 1. H31 layer 4 brick visual and PECIT scans (2019)

56. The Eddy Current results of the 13 channels inspected using the Prototype Eddy Current Inspection Tool (PECIT) do not appear to challenge the visual findings. In one case, additional support had been provided by PECIT to sentence what appeared to be a minor crack in channel H31 layer 4 shown in Figure 1. As PECIT indicated that the crack did not extend or open, it was sentenced as a surface scratch.

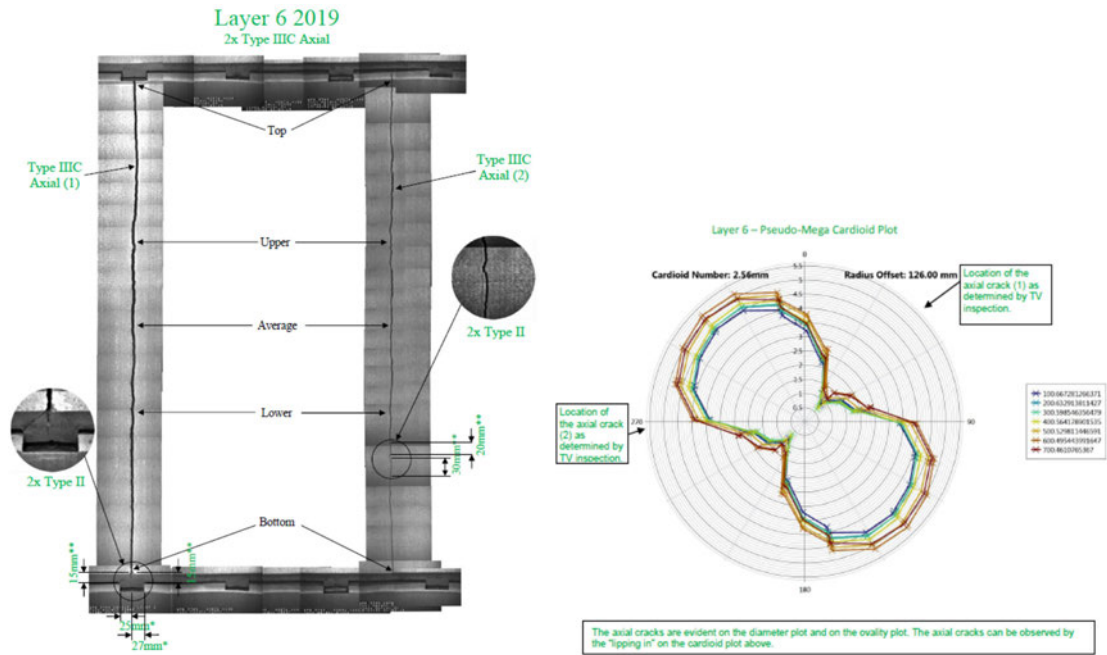
**Figure A1.4.** T09 doubly cracked brick in layer 6 and its cardioid plot (2019)

- T09:** This is a ring 10 double edge channel which had been inspected previously in 2009. In 2019 inspection, it was found to contain cracking in layers 4, 6, 7 and 9. At the time of the 2009 inspection, it had a single crack in layer 6. This is now accompanied by another full height axial crack approximately 135° away from the first crack in addition to secondary damage of the end-face key at the bottom of the original crack as shown in Figure A1.4. The other cracks in the other layers appear similar to those observed in 2009. Based on its bore shape and in line with its sentencing tree, NGL sentenced the cracks in layer 6 as bore cracks, making this brick a doubly bore cracked brick. However, this observation of a doubly bore cracked brick where the

cracks are not diametrically opposite each other is unusual, as most double bore cracks are diametrically imposed.
