ASSESSMENT REPORT			
Unique Document ID and Revision No:	ONR-OFD-AR-18-016 Revision 0	TRIM Ref:	2018/202683
Project:	Heysham 2 Reactor 7 2018 Periodic Shutdown		
Site:	Heysham 2		
Title:	Heysham 2 Reactor 7 2018 Periodic Shutdown: Structural Integrity Assessment of the Graphite Core Inspection Findings, including Consideration of EC 356531		
Nuclear Site Licence No:	588		
Licence Condition(s):	30, 28		
ONR Assessment Rating (Mandatory): <i>(Rating should be based on licensee's original safety case submission)</i>	GREEN		
COIN Service Order:	SVC4285368

**Heysham 2 Reactor 7 2018 Periodic Shutdown – Assessment of the results of the
Graphite Core Inspections**

Assessment Report ONR-OFD-AR-18-016
Revision 0
29 June 2018

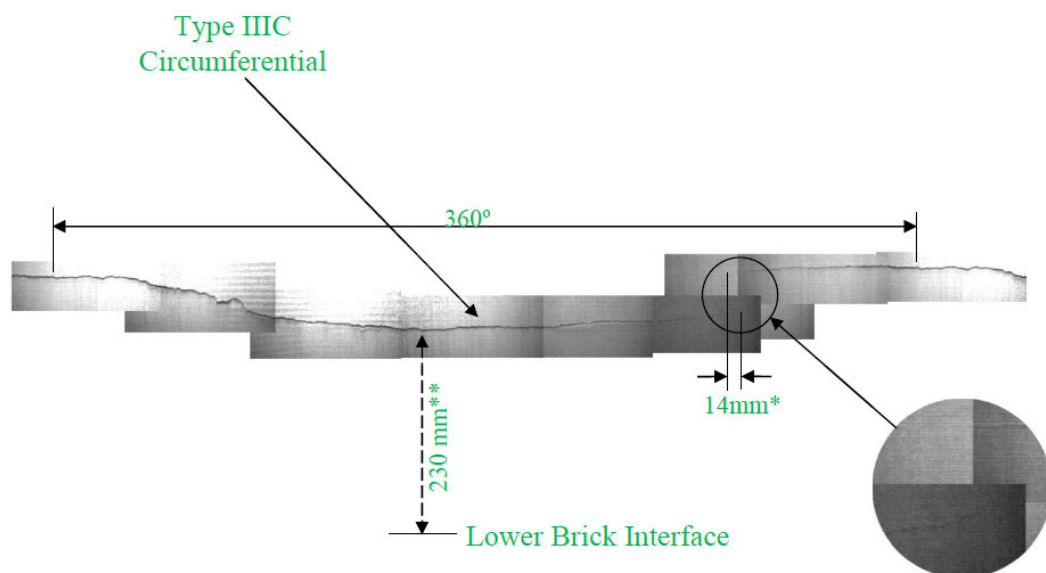
Figure 3: Circumferential crack observed in fuel channel K35, layer 8 (Reference 26).

50. The brick and channel distortions measured were within expectation. The control rod channel did not reveal any defect. The results of these inspections are therefore as expected and do not challenge the assumptions of the safety case.

- 51. This is the second circumferential bore crack observed in the HYB R7 graphite core (see Table 1 of Reference 15). No full height axial crack has yet been observed in this reactor although two smaller cracks have been observed ('Type IIIA' as per Table 1 of Reference 15). I therefore consider that the results of these inspections do not challenge the licensee's 'intact core' definition, i.e. 10% cracking.

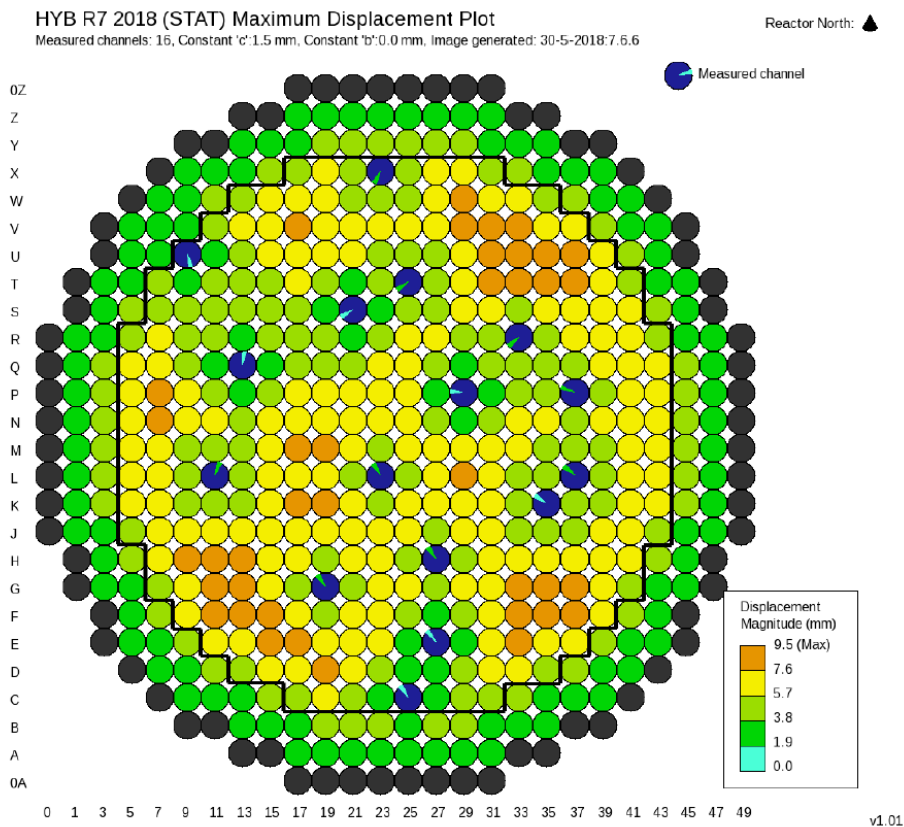
Figure 4: Core distortion map calculated using Core Distortion Pinning program.

- 53. The displacements in Figure 4 show that the channel displacement relative to the base layer is generally less than 9.5mm. Measured core distortions of channel tilt and bow appear to be similar, or not significantly worse, than previous core measurements. Therefore, I do not expect this level of distortion to be a concern for the safety of the core.

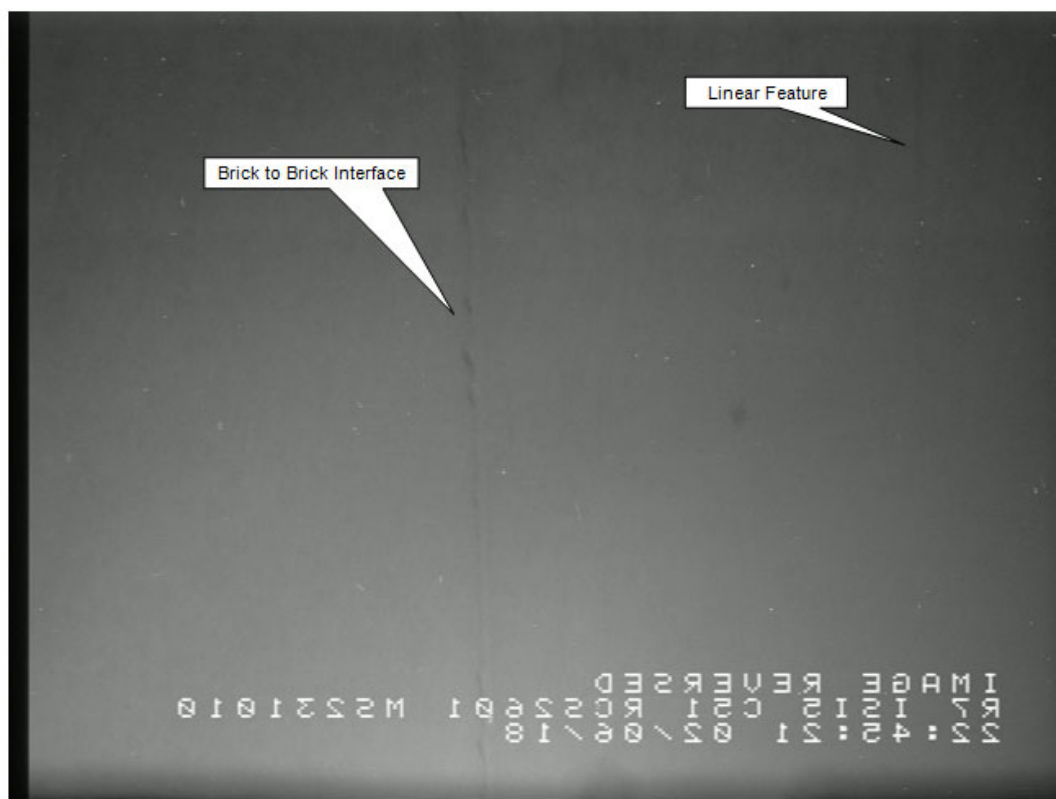
Figure 5: Peripheral Wall Inspection W092/05 – Layer 3, Face 16, Brick 8: example of 'missing graphite'.

64. Figure 5 shows eroded pieces of graphite at the interface between the peripheral wall bricks. This was classified as 1.8 (linear feature) by the PBAP. During the meeting, I asked the PBAP members for clarification concerning the missing pieces of graphite. NGL explained that the size of the missing edges of the graphite brick was small, ~0.5mm, and noted that it was most likely a machining mark or a scratch. The PBAP did not consider this to be significant and confirmed that a classification of 1.8 was appropriate.

65. In my opinion, the resolution of the camera does not allow for a definitive conclusion to be drawn. However, I consider that these defects are small and do not present a crack-like feature. I therefore do not consider that these are likely to be of any significance for the integrity of the core.

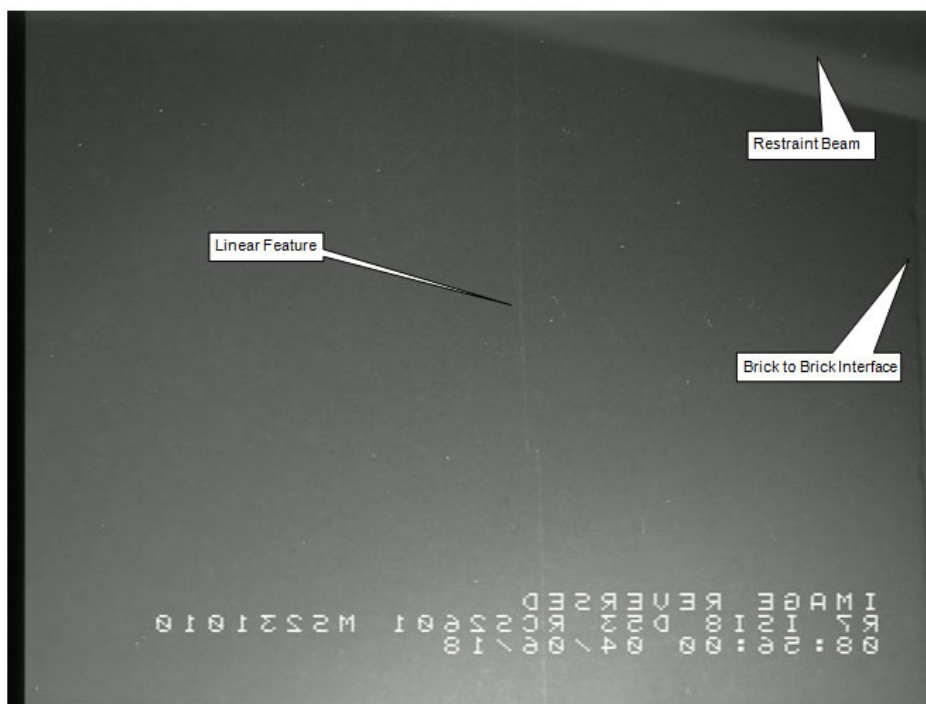
Figure 6: Peripheral Wall Inspection W108/02 – Layer 1, Face 11, Brick 7: linear feature.

68. The two defects shown in Figure 6 are relatively straight and do not seem to exhibit a marked thickness through the brick. Also, the two marks do not join up and abruptly stop at a very close distance. This suggests that there is no active mechanism to drive the defects to join up. I therefore conclude that the features shown in this figure are unlikely to be cracks and that machining marks or score marks during installation could be a possible cause for these defects. As a comparison, Figure 7 shows a linear crack (inspection sheet W081/02 in Reference 28).

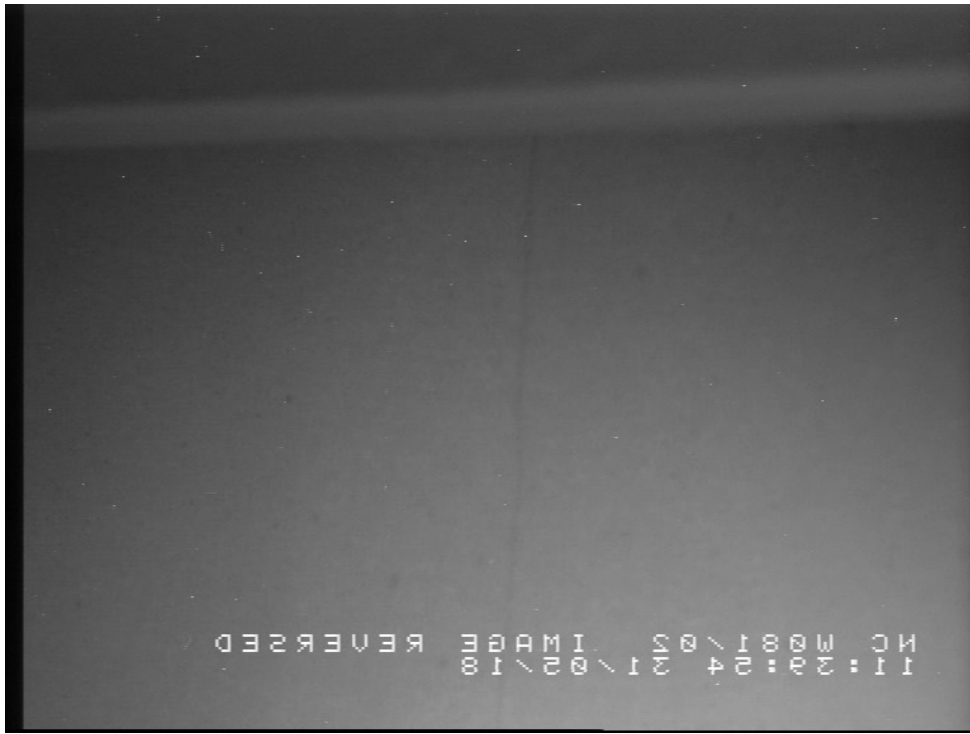
Figure 7: Peripheral Wall Inspection W081/02 – Layer 1, Face 4, Brick 6: linear crack.

69. The defect shown in Figure 7 is not as straight as a linear feature and seems to be show darker edges, suggesting deeper propagation into the brick than linear features. The peripheral bricks inspections also showed that there could be some damage local to the corners, such as shown in Figure 8.

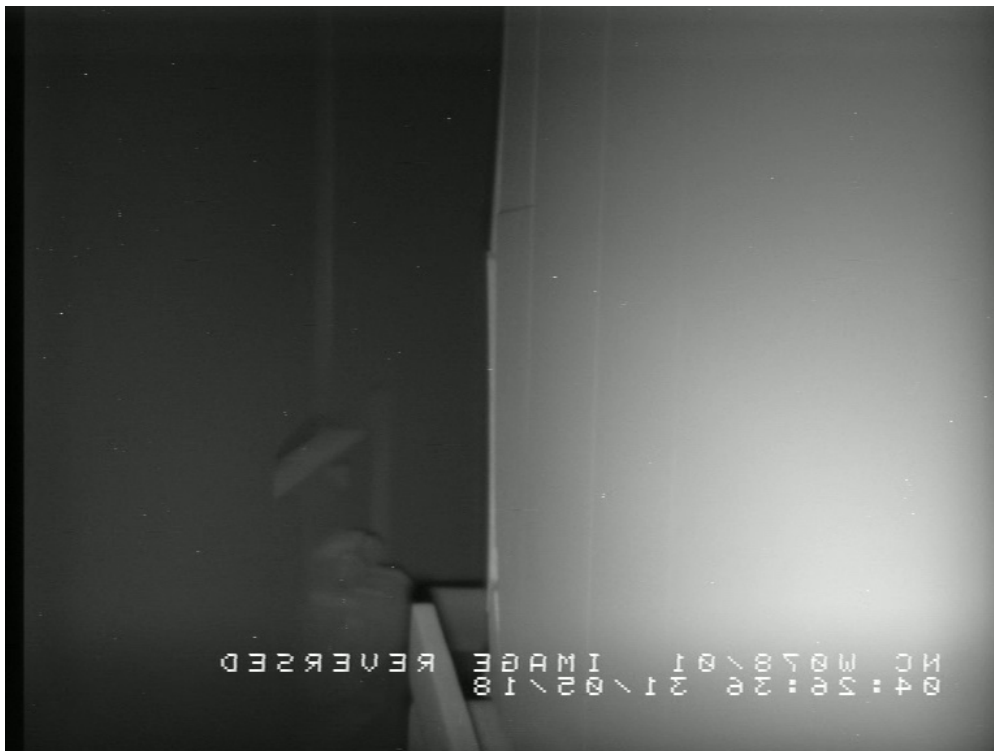
Figure 8: Peripheral Wall Inspection W078/01, Layer 10, Face 3, Brick 1: corner crack.

70. The type of damage shown in Figure 8 indicates cracking at the corner between the faces. I consider that this type of defect could be significant due to the potential for a panel to generate debris, disturb the cooling flow around the core or create some distortion of the core in the nearby fuel and control rod channels.
