ASSESSMENT REPORT			
Unique Document ID and Revision No:	ONR-OFD-AR-18-003 Revision 0	TRIM Ref:	2018/144215
Project:	Hinkley Point B Reactor 4 2018 Periodic Shutdown		
Site:	Hinkley Point B		
Title:	Hinkley Point B Reactor 4 Periodic Shutdown: Structural Integrity Assessment of the Graphite Core Inspection Findings		
Nuclear Site Licence No:	62C		
Licence Condition(s):	LC 30		
ONR Assessment Rating (Mandatory): <i>(Rating should be based on licensee's original safety case submission)</i>	GREEN		
COIN Service Order:	SVC4285368

**Hinkley Point B Reactor 4 Periodic Shutdown 2018 – Graphite Structural Integrity
Assessment**

Assessment Report ONR-OFD-AR-18-003
Revision 0
May 2018

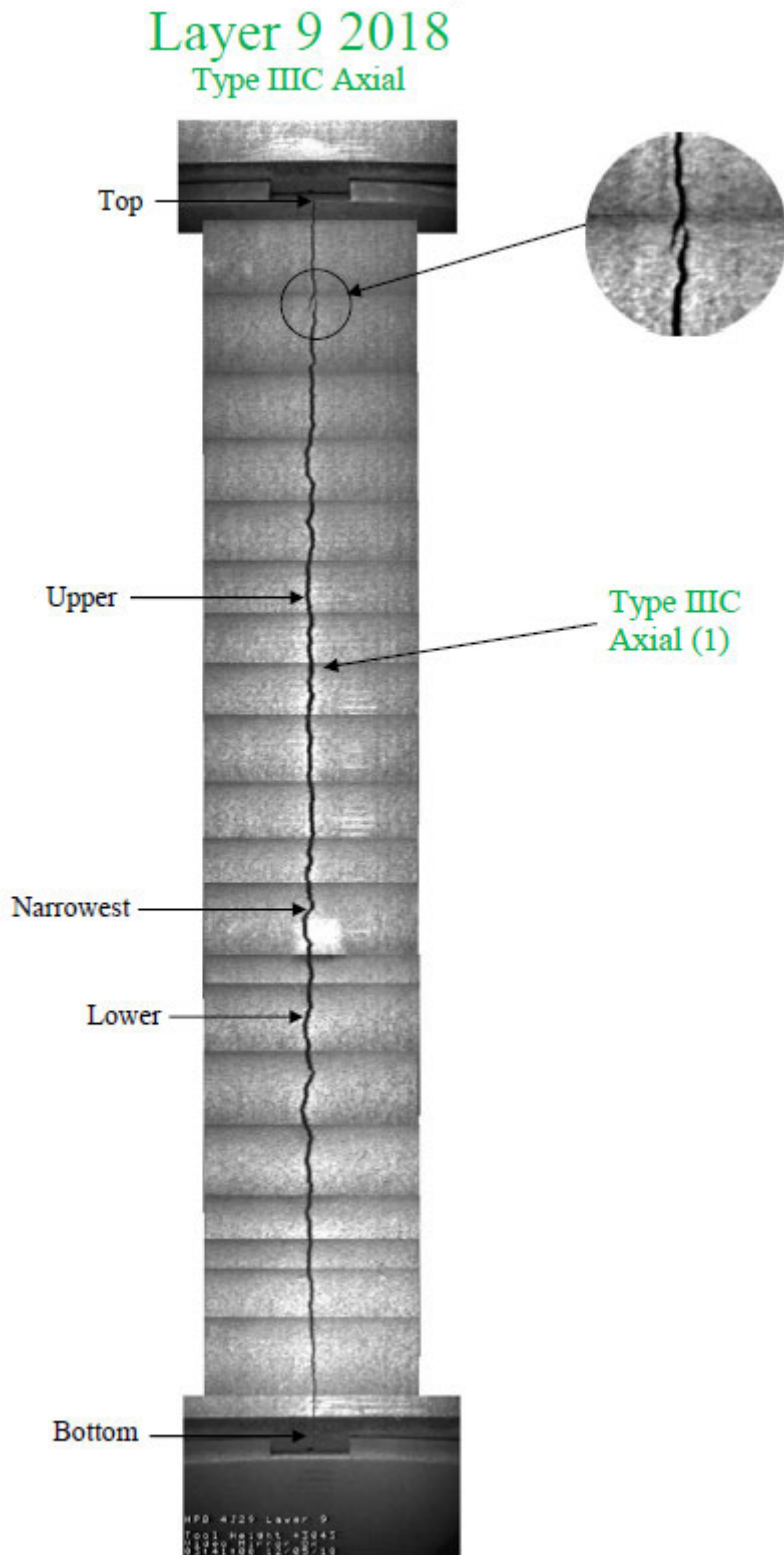
Figure 1: Full axial bore crack observed in Layer 9 of Channel J29.

34. This crack presents some features common to KRCs, close to a keyway, relative straightness. However, its cardioid plot shows the 'lipping-in' which is characteristics of bore cracks and is associated with the tensile stresses increasing at the bore in early life of the graphite; see Figure 2.

- 35. In Figure 2, the '100' location corresponds to the top brick in the channel and '700' corresponds to the lowest brick. It follows from these measurements that the crack observed is a bore crack and was sentenced as such by the GAP.

- 36. Since bore cracking is considered to be an early-life phenomenon, the total number of such cracks in the reactor is unlikely to change and newly observed bore cracks only highlight the fact that the channels had not been previously inspected. The estimates for the number of single axially cracked bricks are below the safety case allowance. I expect that this level of bore cracking will not significantly progress as the core ages. NGL considers circumferential cracks to be relatively benign for the structural integrity of the core because of their relatively low instance. This judgement was considered to be reasonable in ONR's assessment of NP/SC 7662 (Ref. 17).

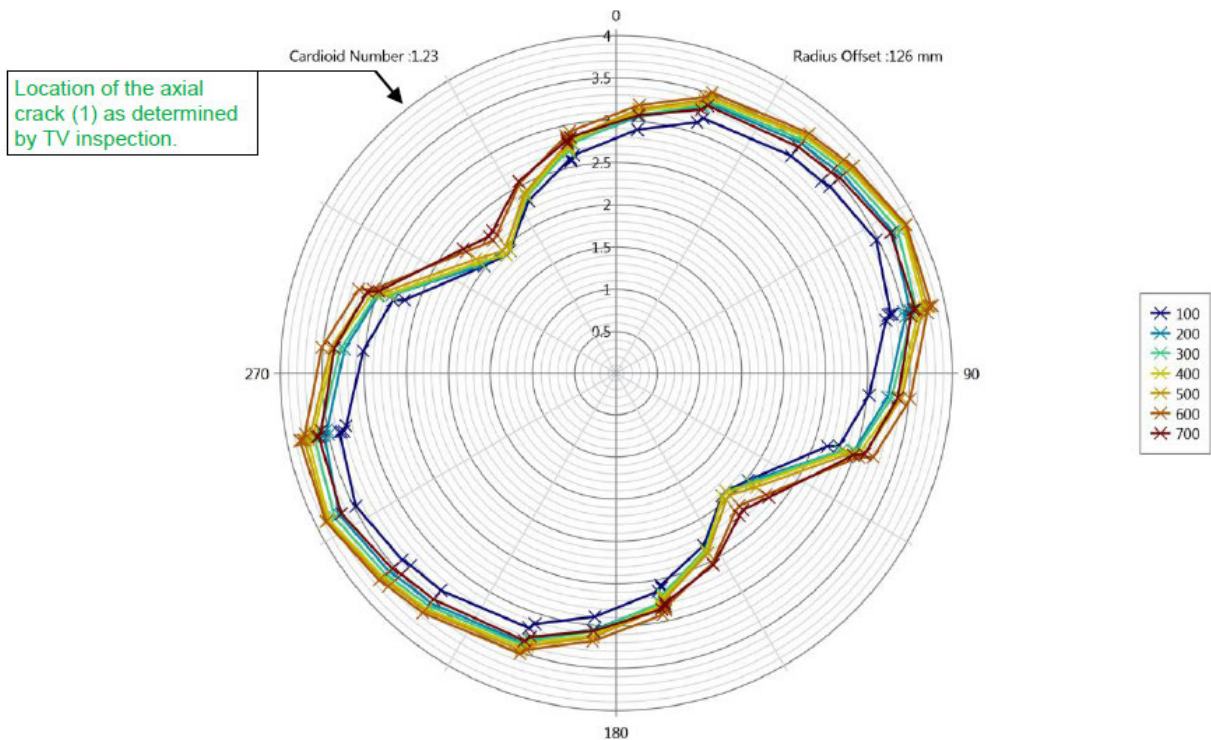
Layer 9 – Pseudo – Mega Cardioid Plot

Location of the axial crack (1) as determined by TV inspection.

The axial crack is not evident on the diameter plot or on the ovality plot. The axial crack can be observed on the cardioid plot above.

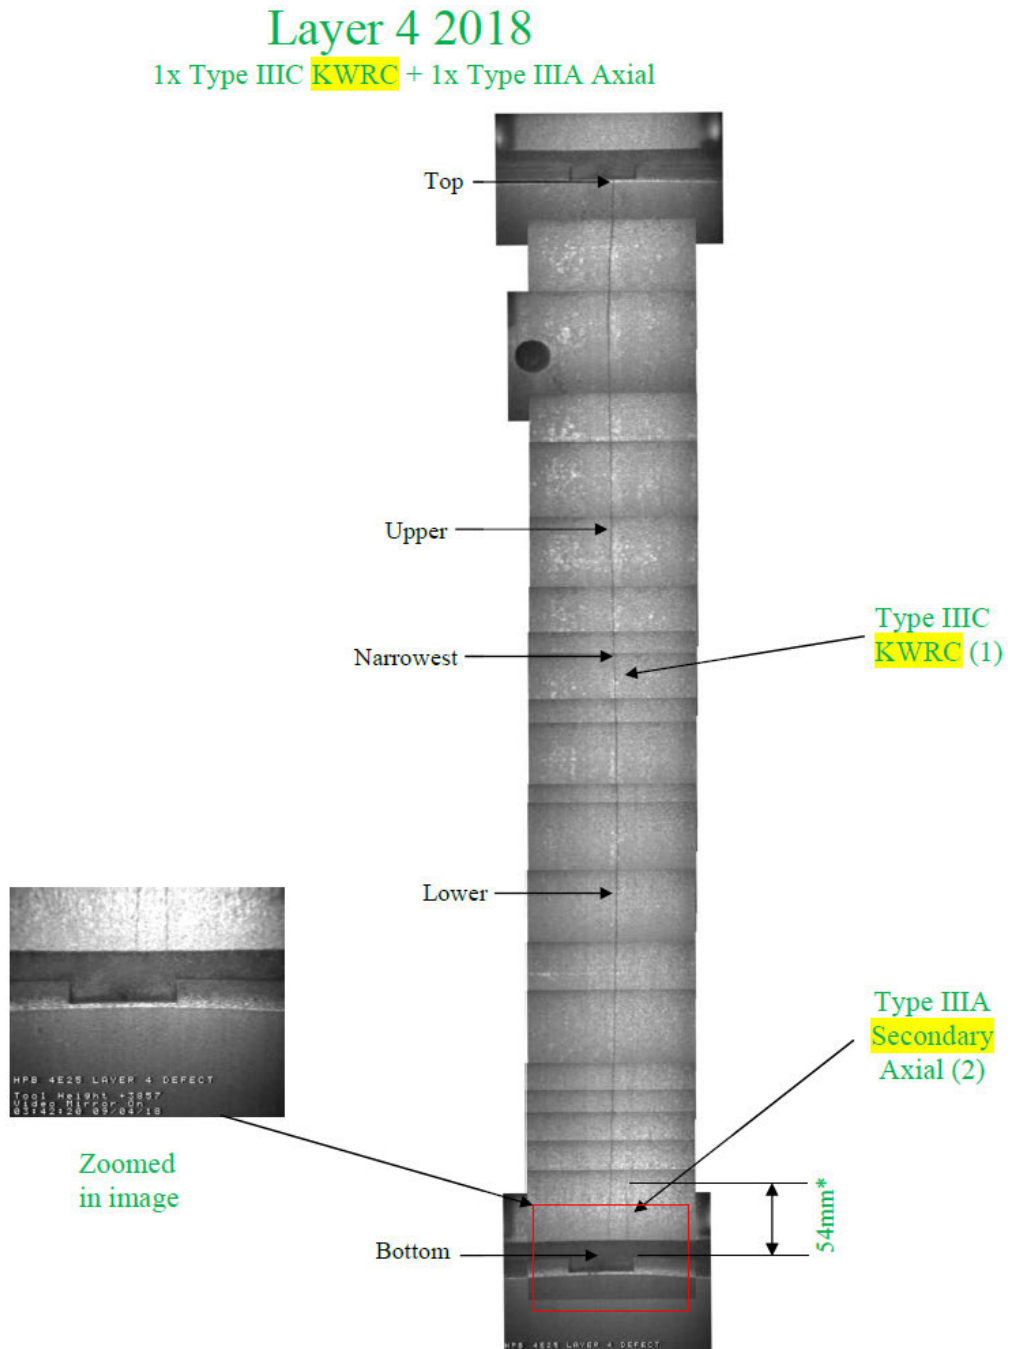
Figure 3: KRC in Channel E25, layer 4.

40. This figure also shows evidence of secondary damage from the primary keyway root crack at the corner of the end face. This channel had been inspected in 2002, 2005, 2011 and 2015 and was targeted due to previous low 'lambdas'.

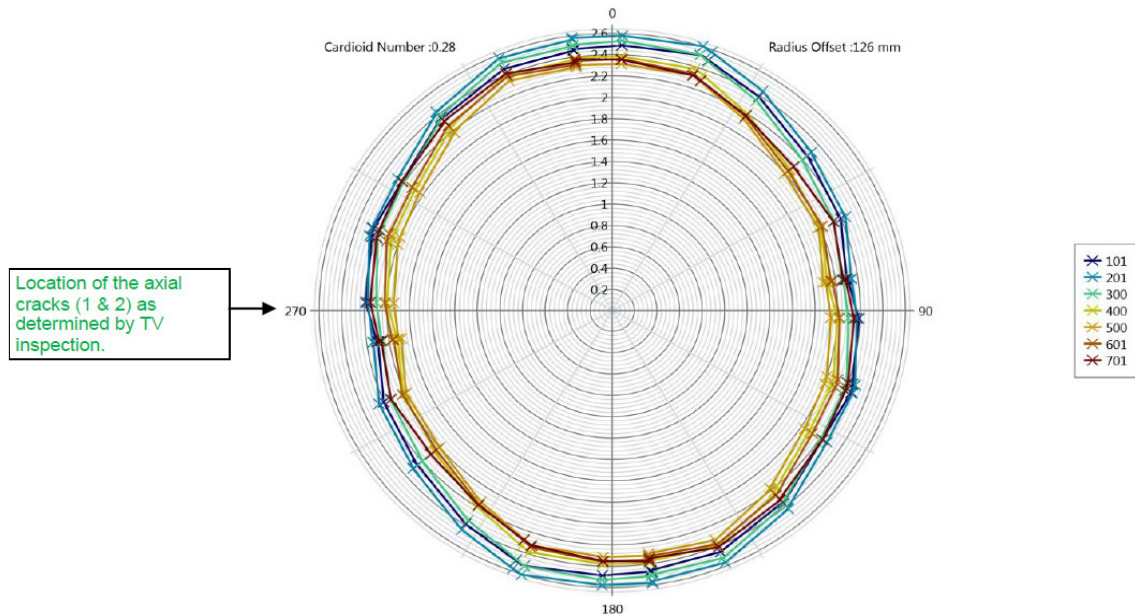
Figure 4: Cardioid plot derived from the bore measurements in Channel E25.

41. Figure 4 shows the cardioid plot for channel E25 which confirms the absence of lipping-in and the sentencing as a KRC. From a structural integrity point of view, KRCs are more significant than bore-initiated cracks since NGL expects their number and the crack opening to increase over time. NGL has developed some models to predict the number of cracks expected during the inspections and make an estimate on the total number of cracks in the core. This observation is therefore consistent with NGL's expectations.

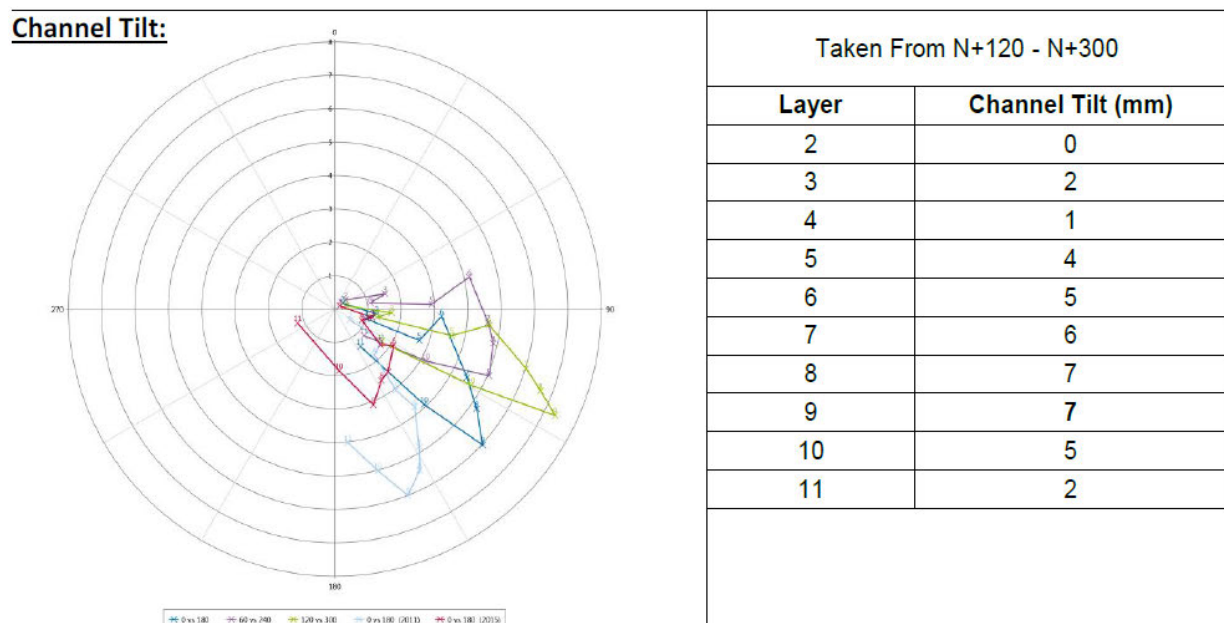
47. During the inspections, NGL notified ONR that one of the transducers, T1-3, was faulty and gave an artificial rotation of the measurements compared to historic data. This is illustrated in Figure 5 below. The licensee also reported that additional twisting the NICIE2 tool could occur during inspections. This twisting was previously accounted for by using an additional factor to represent the difference in average tool twist between the two scan pairs.

Figure 5: Tilt measurement plot for Channel L15 (Ref. 19).

48. NGL subsequently repaired the faulty transducer and analysed the data recorded using the faulty transducer. The licensee subsequently reviewed the recent inspection data produced in a short note in Ref. 20. This note identified that the fault occurred in

51. However, although the licensee was able to detect this fault relatively early this time, there are insufficient checks of the quality of the inspection data when it is being collected from the channel to identify the fault during the inspection. This meant that several channels were inspected before the fault was realised by the GAP's interrogation of the tilt results. ONR has therefore recommended to the licensee (at HNB) in Ref. 22 that further improvements should be made to confirm the quality of the data collected from a channel before moving to inspect the next channel. I am adding this as a recommendation to the licensee to reinforce this expectation.

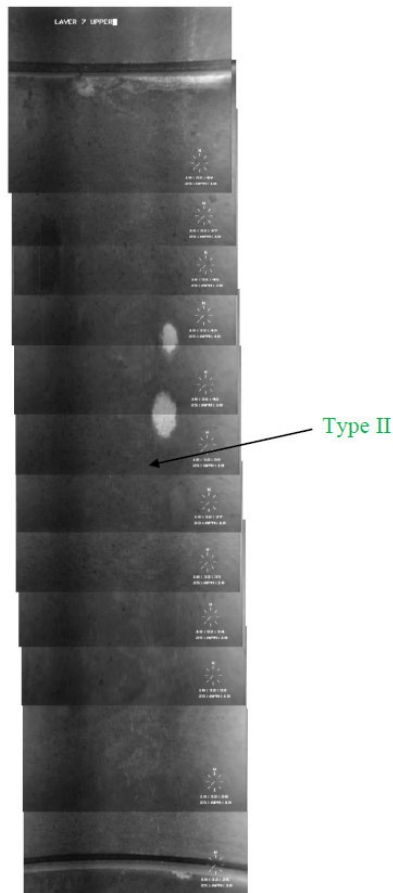
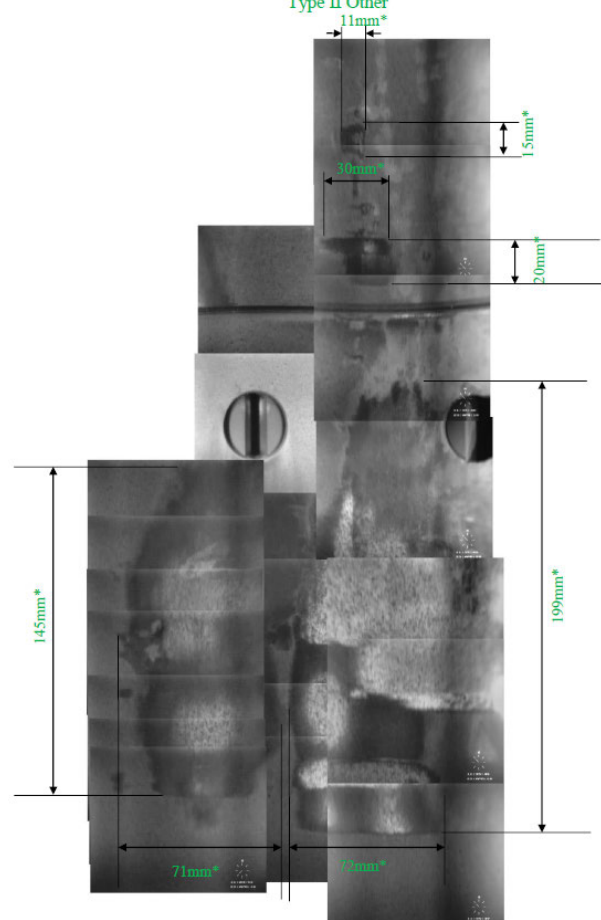
Layer 7 upper 2018

Type II Other

Layer 2 lower/upper 2018

Figure 6: Marks in (a) Layer 7 and (b) Layer 2 of Control Rod Channel RS28.

53. These defects were considered by the GAP who classed these defects as 'Type II – Features that could grow into cracks if stresses are sufficient, and cracks of a length that implies existence prior to irradiation non-propagating defect' (Ref. 23).

55. Following ONR's request, the licensee provided some possible explanation for the damage observed in Ref. 24. According to the licensee, the markings observed may have been caused by contact by the control rod during drops, original defects, inspection equipment or the removal of the control rod shock absorbers to allow sub-diagrid viewing. The licensee also mentions that this type of damage had not been observed before, but that similar scuff marks have been observed in fuel channels where the stabilising brushes interact with the channel walls. According to NGL, the

58. Given that damage of the type observed has not previously been observed in other control rod, I recommend that control rod channels housing super-articulated control rods of similar manufacture and from the same manufacturer (IMI 'contract' rods) should be considered for further inspection, both at HPB and HNB.

- **Recommendation 4 (to NGL Graphite Group Head):**
In light of the observations in control rod channel RS28, I recommend that the licensee considers performing further inspections of control rod channels at Hunterston B housing super-articulated controls, which are of similar manufacture and from the same manufacturer as those for the control rod corresponding to channel RS28.
