Hinkley Point B Decommissioning EIA Baseline Report: Invertebrates

Verification of Terrestrial Biodiversity Baseline

Biodiversity Net Gain: Baseline

Intertidal Validation Survey October 2022  
for Hinkley Point B Nuclear Power Station

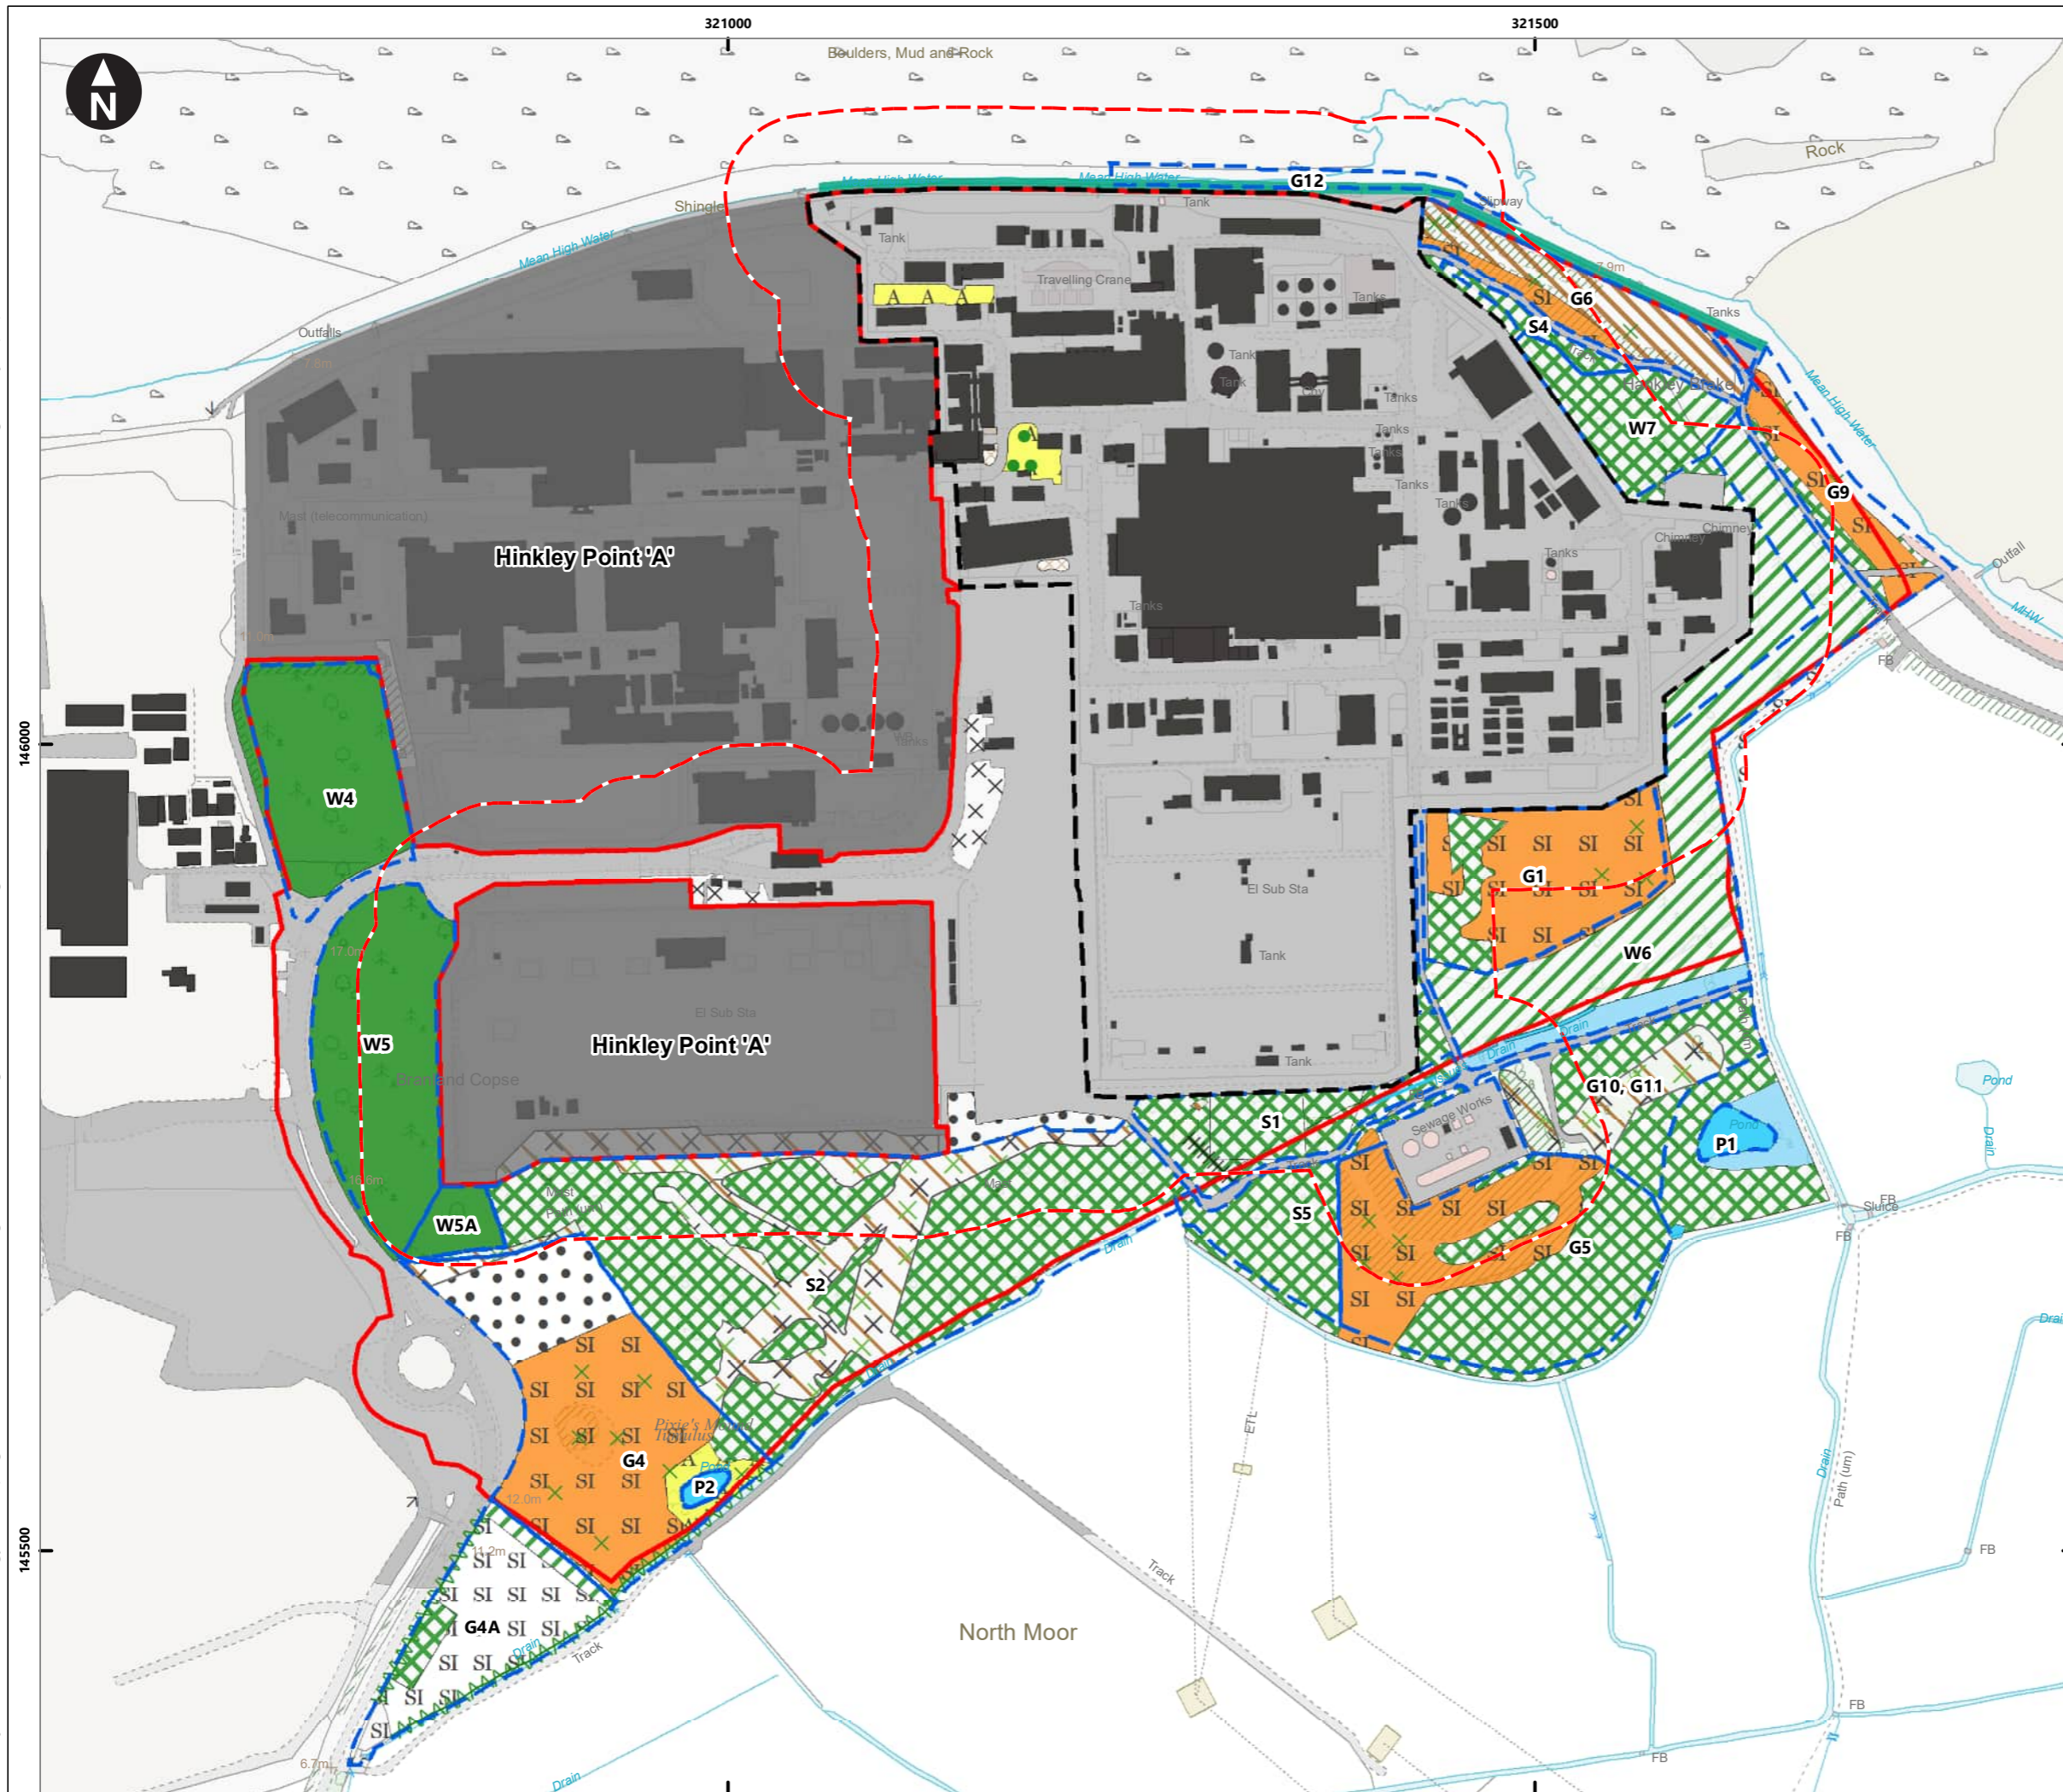
**Figure 2.1**  
Study area

- Hinkley Point B Nuclear Site Licence boundary
- Double security fence
- G4 Habitat compartment
- 50m buffer
- Broadleaved woodland - semi-natural
- Broadleaved woodland - plantation
- Scrub- dense/continous
- SI SI Neutral grassland - semi-improved
- SI SI SI Poor semi-improved grassland
- Tall ruderal
- Ephemeral/scrub/ruderal mosaic
- Swamp
- Standing water
- A A A Amenity grassland
- Introduced shrub
- Buildings
- Bare ground
- Hardstanding
- Running water
- Intact hedge native species-rich
- Fence
- Sea wall
- × Scrub - scattered
- Parkland and scattered trees-broad-leaved
- × Short ephemeral

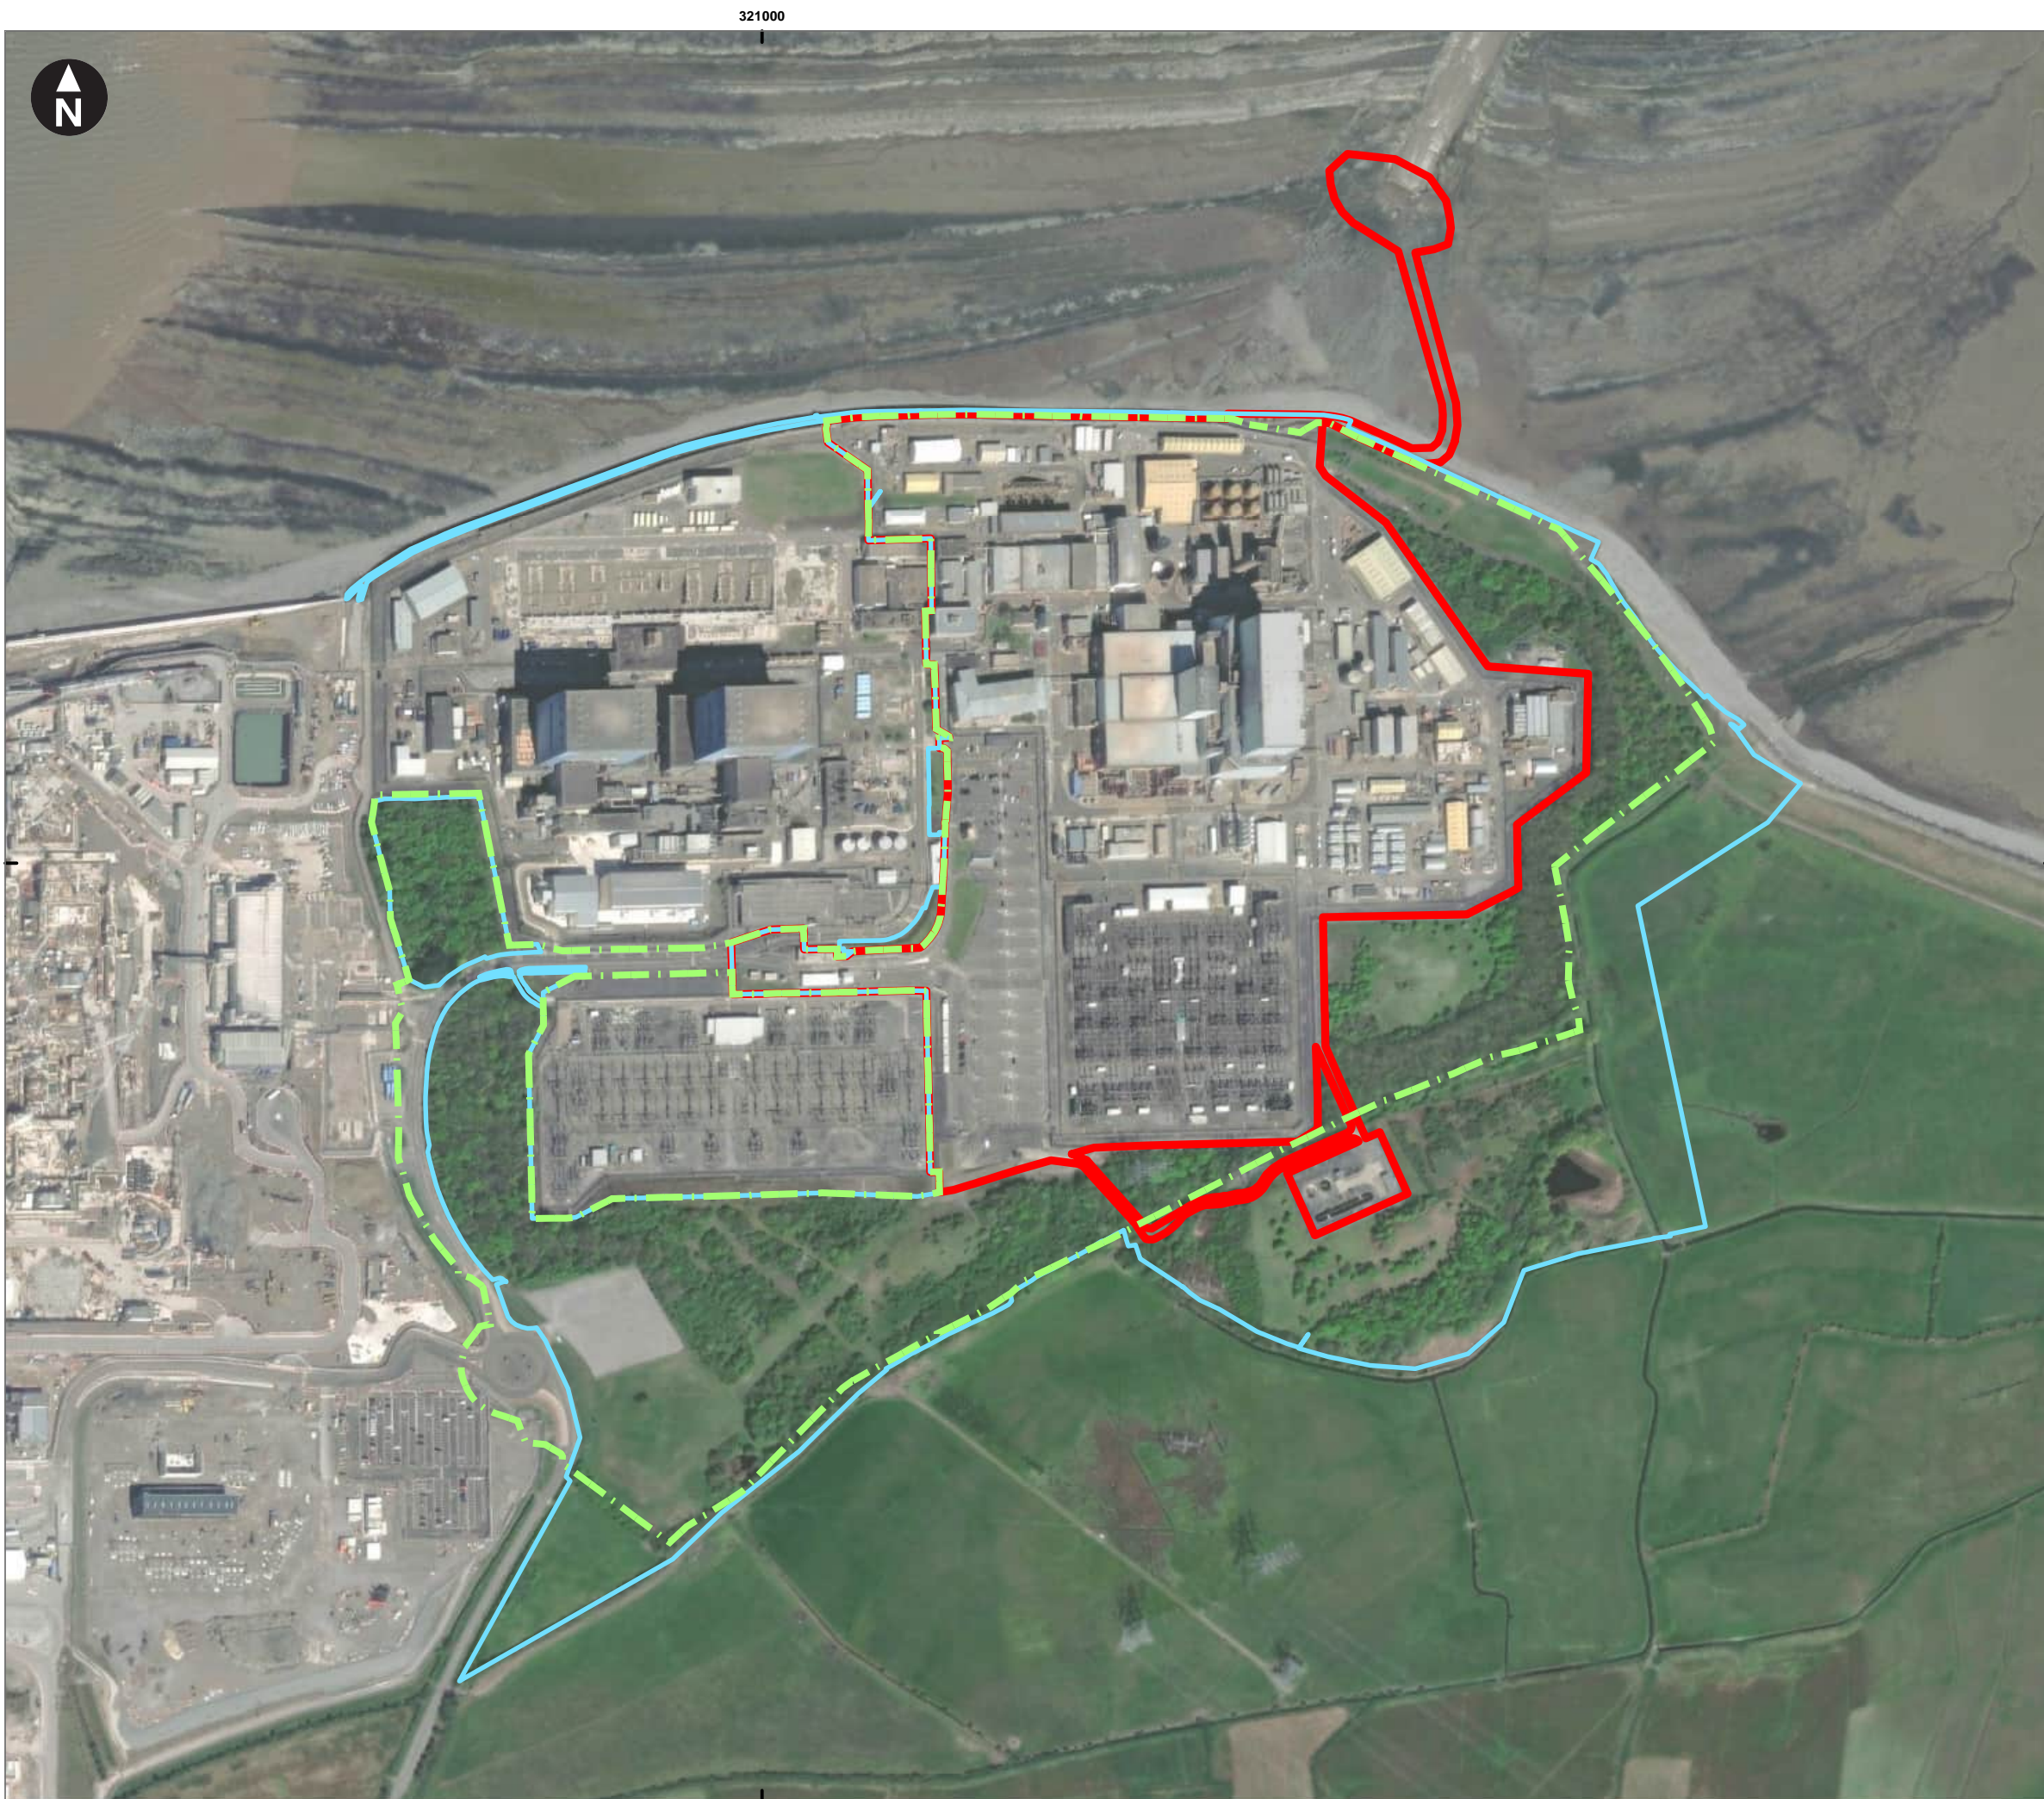
**Figure 1**  
**Site, Works Area and NSL Boundaries**

- Key
- Study Area
  - Indicative Dismantling Works Area ("Works Area")
  - - - Nuclear Site Licence Boundary ("NSL")

- 1.1.3. EDF is exploring opportunities for the Proposed Works to deliver an overall increase in biodiversity, referred to as Biodiversity Net Gain (BNG). The Study Area encompasses the land covered by the NSL (also referred to as 'The Site'), the Works Area and areas of adjacent non-operational land that are owned by EDF. These areas are shown in **Figure 1 (Appendix A)**.

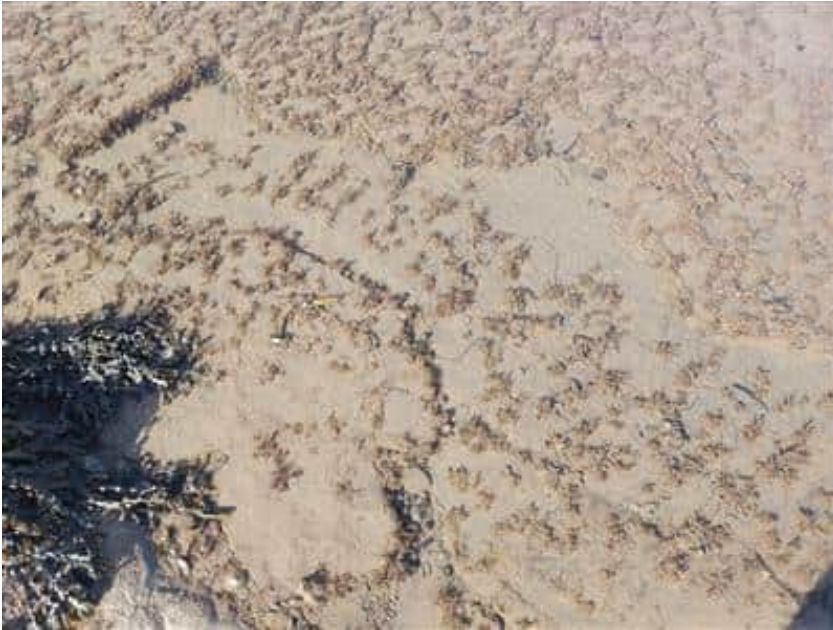
- 3.2.15 In the western upper to mid shore environment and the eastern mid shore there were areas of Coralline crusts and *Corallina officinalis*. This biotope was recorded in shallower rockpools/channels between the limestone layers. Some of the rockpools had *Ulva* spp. as well as winkle *Littorina littorea* and the anemone *Actinia equina* present.
- 3.2.16 The observations during the habitat validation survey were broadly consistent with the presence and extent of this biotope recorded during the 2020 Phase 1 habitat survey, indicating no significant change.

### Photo 3.7 Biotope LR.FLR.Rkp.Cor.Cor observed in rockpools

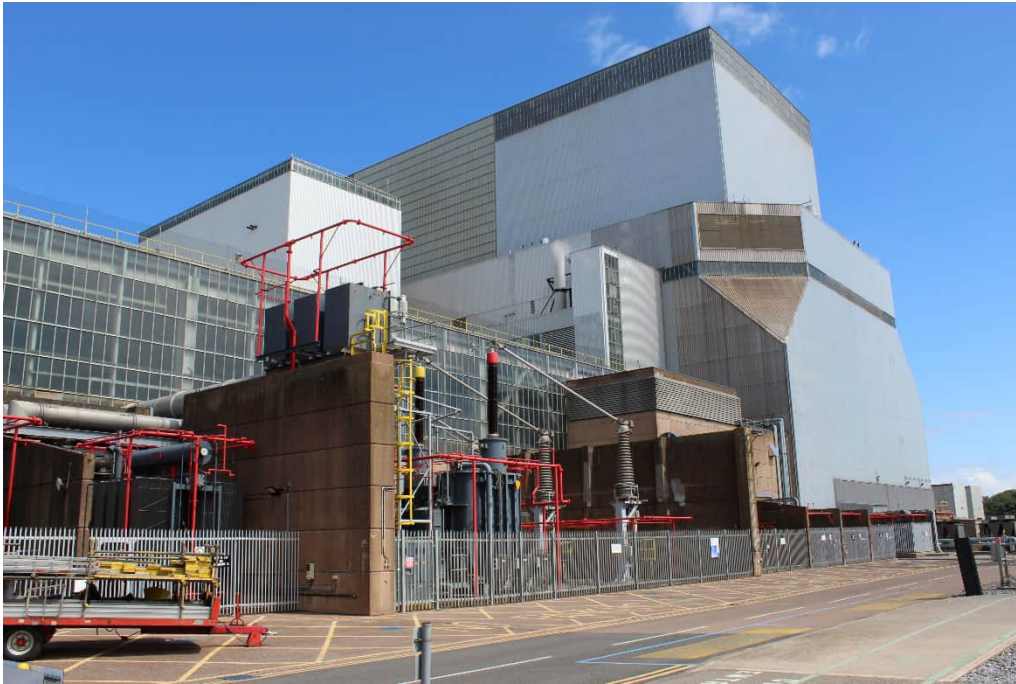
Plate 1. The original turbine hall and reactor building. View north-east.

The original turbine hall and reactor buildings are in the central area of the Site (**Plates 1-2**).

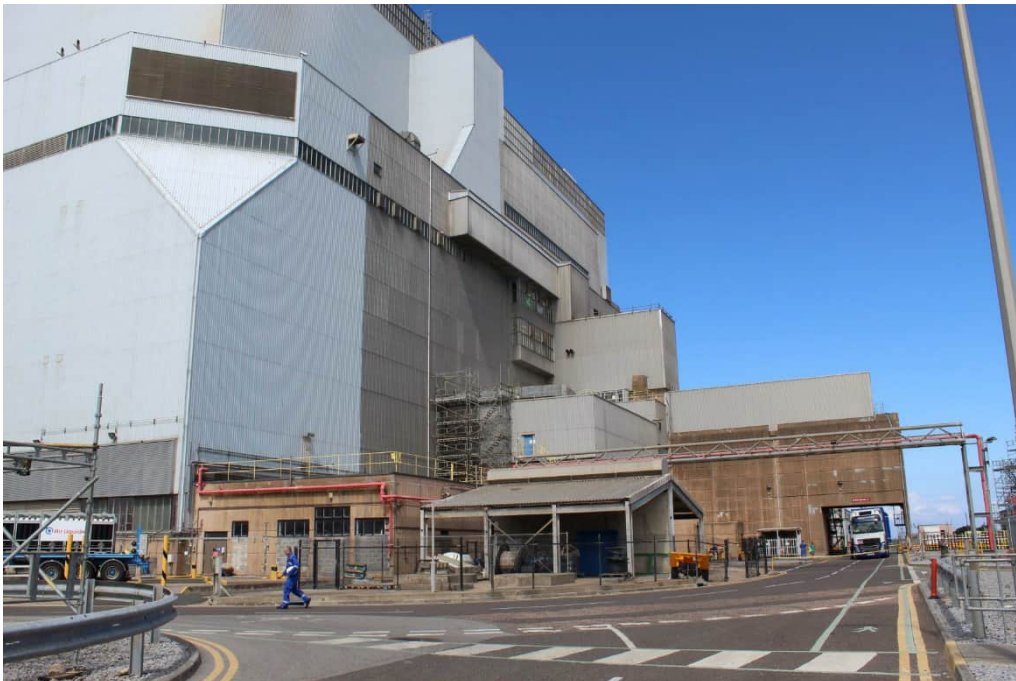
Plate 2. The reactor building. View north-west.

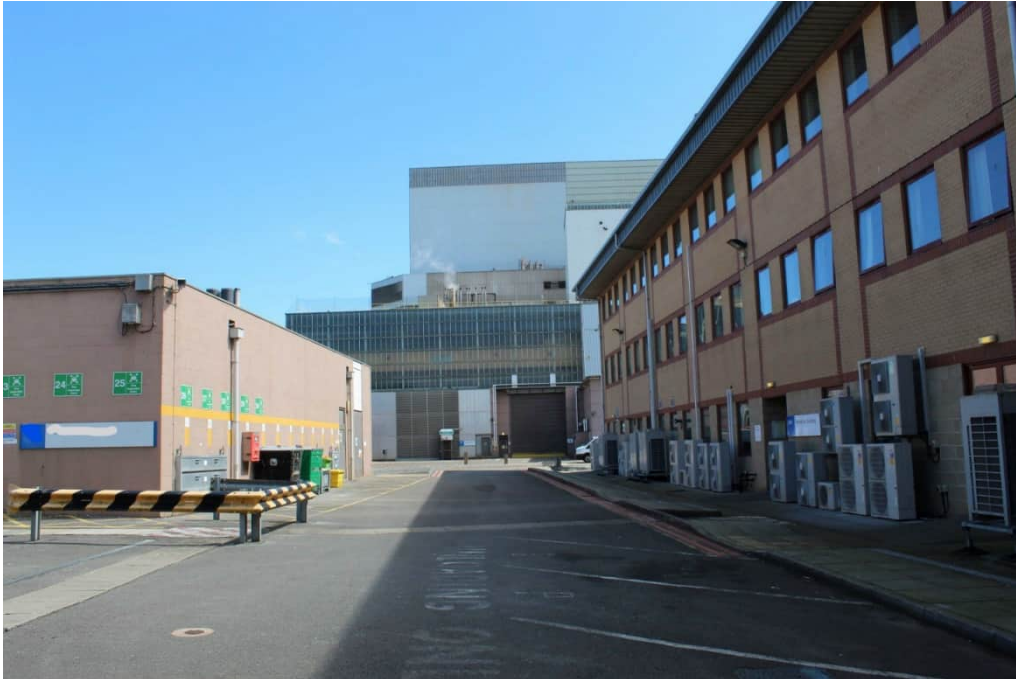
Plate 3. Original ancillary building and modern office building in western site area, with original Hinkley Point B turbine hall in the background. View east.

There is a mixture of original and modern ancillary buildings in the western area of the Site (**Plate 3**).

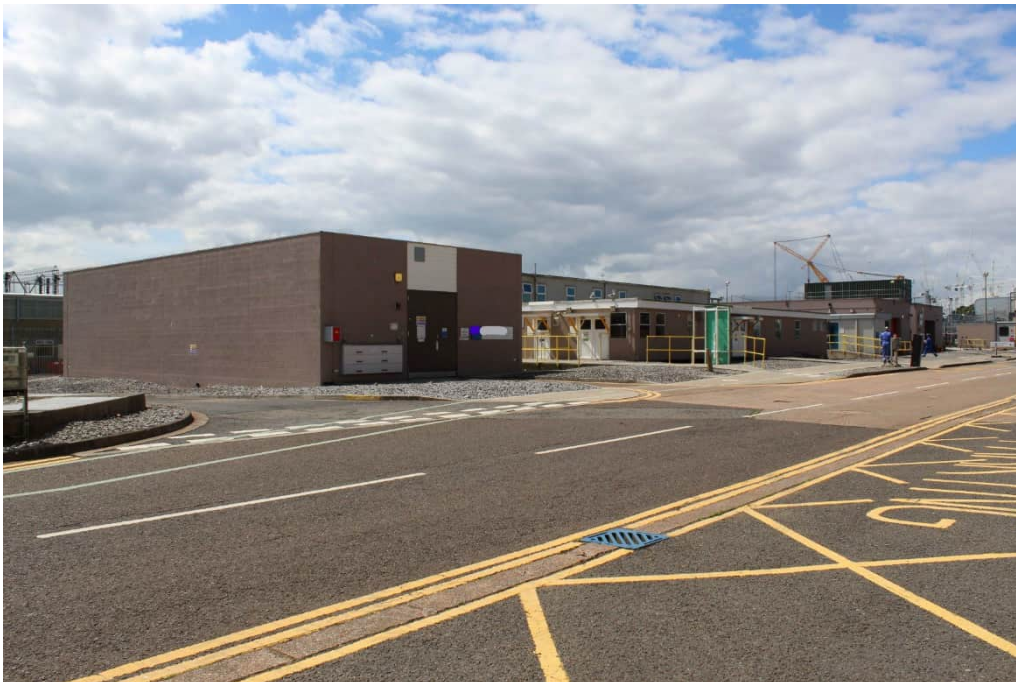
Plate 4. Original ancillary buildings and modern cabins to the south of the turbine hall. View south-west.

There is a mixture of original and modern buildings in the southern area of the Site (**Plates 4-7**).

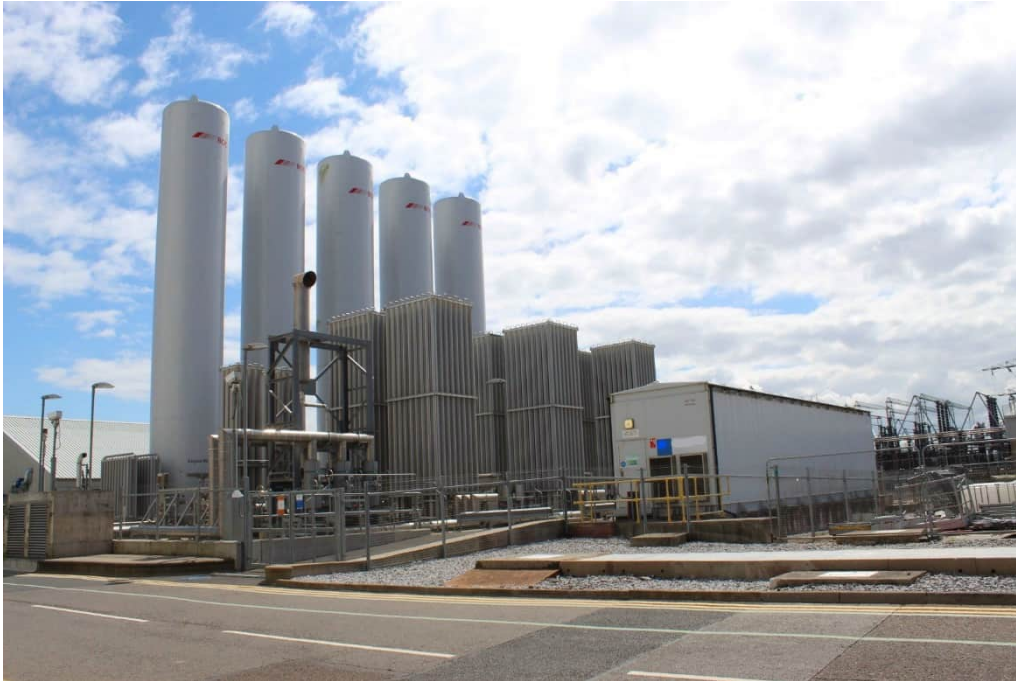
Plate 5. Modern plant to the south of the reactor building. View south-east.

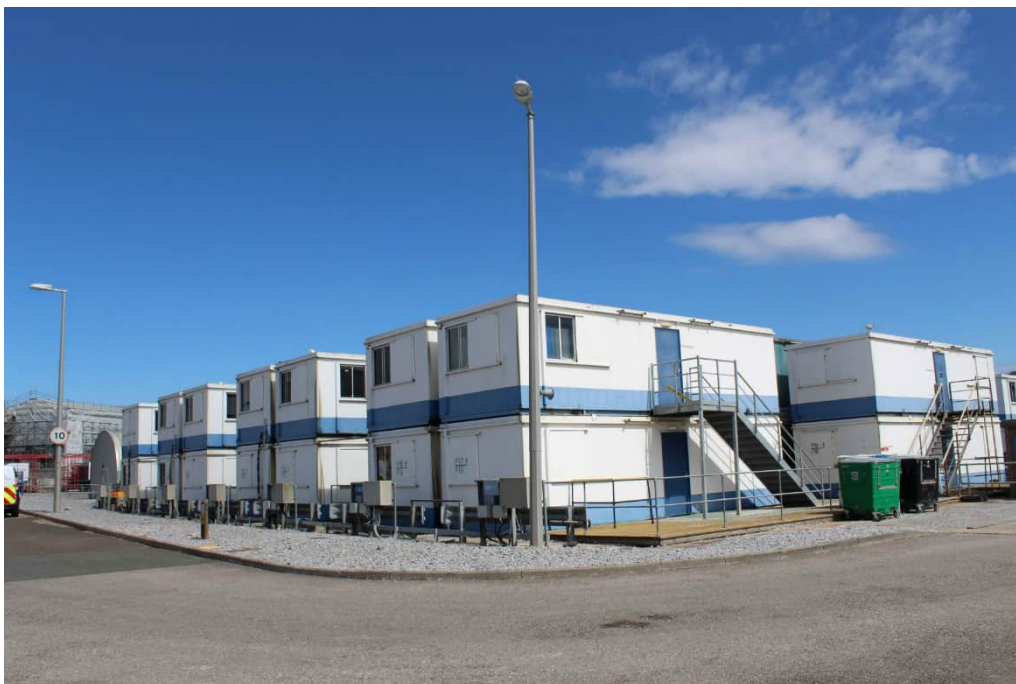
Plate 6. Area of modern cabins to the south-east of the reactor building. View north.

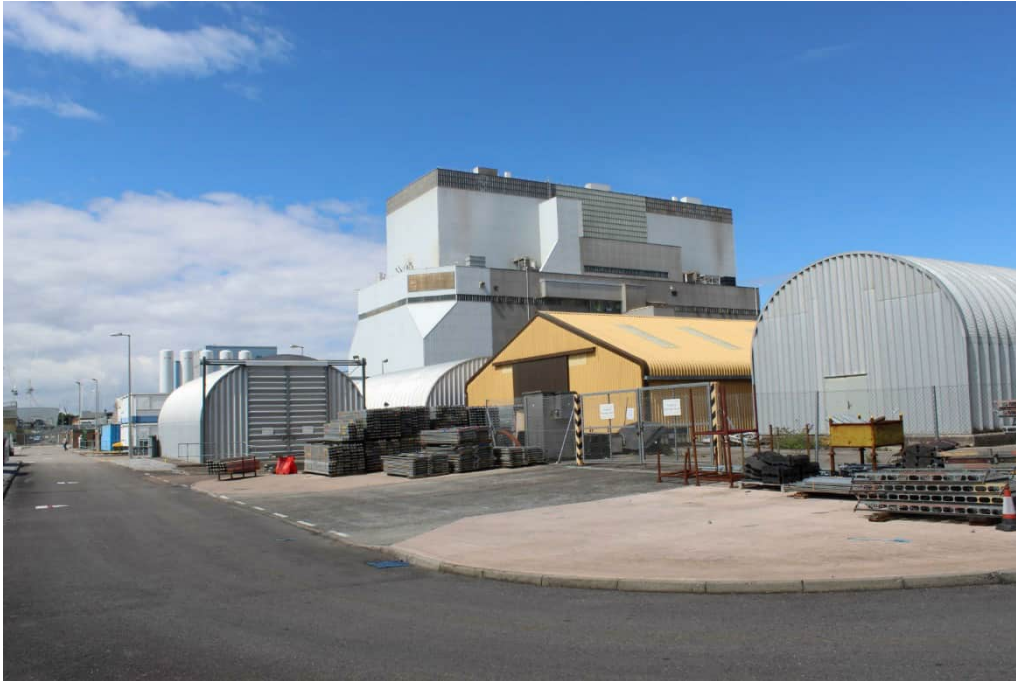
Plate 7. Area of modern and original ancillary buildings in the south-east corner of site. View north-west.

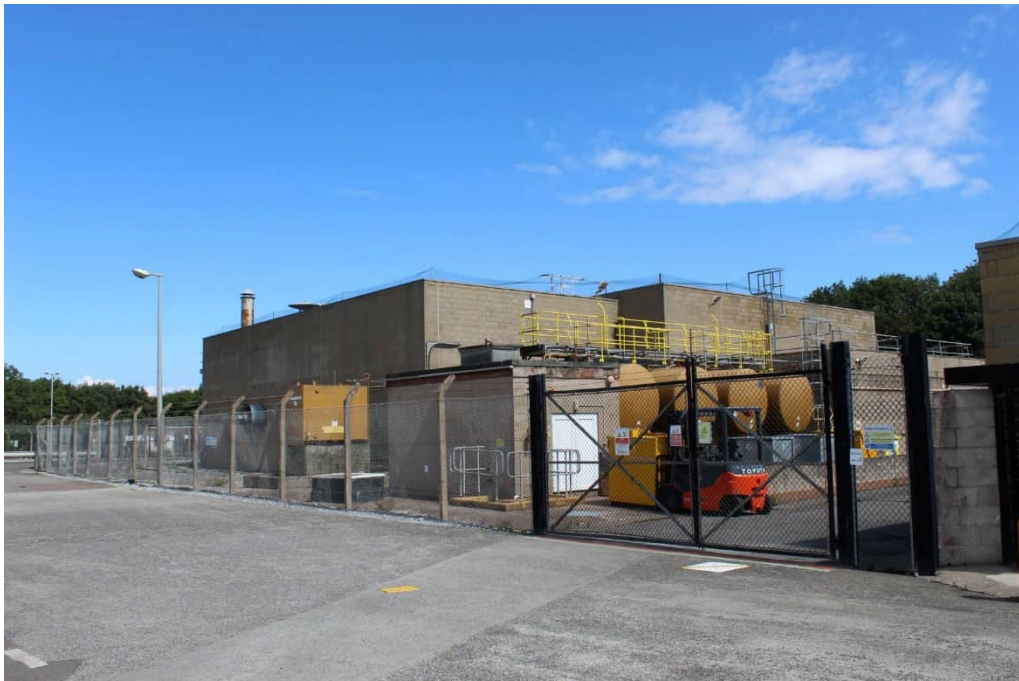
Plate 8. Original ancillary building in the eastern site area. View north-east.

There was a majority of original buildings in the eastern area of the Site (**Plates 8-9**).

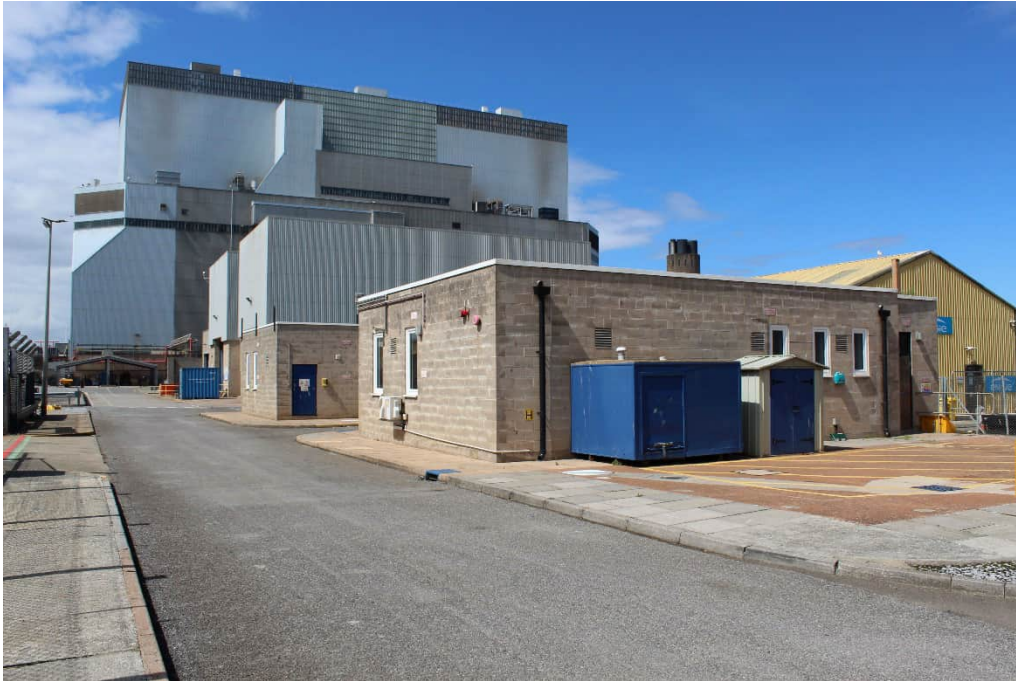
Plate 9. Original ancillary buildings in the eastern site area. View north-west.

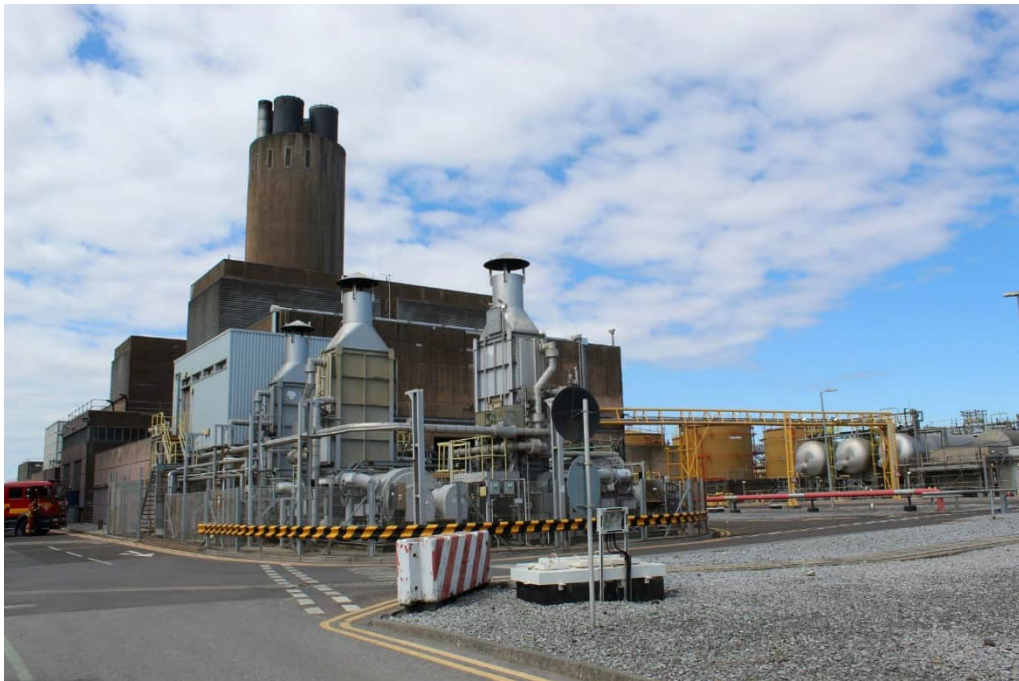
Plate 10. Original and modern ancillary buildings to the north of the reactor building. View north-west.

There was a mixture of original and modern buildings in the northern area of the Site (**Plates 10-14**).

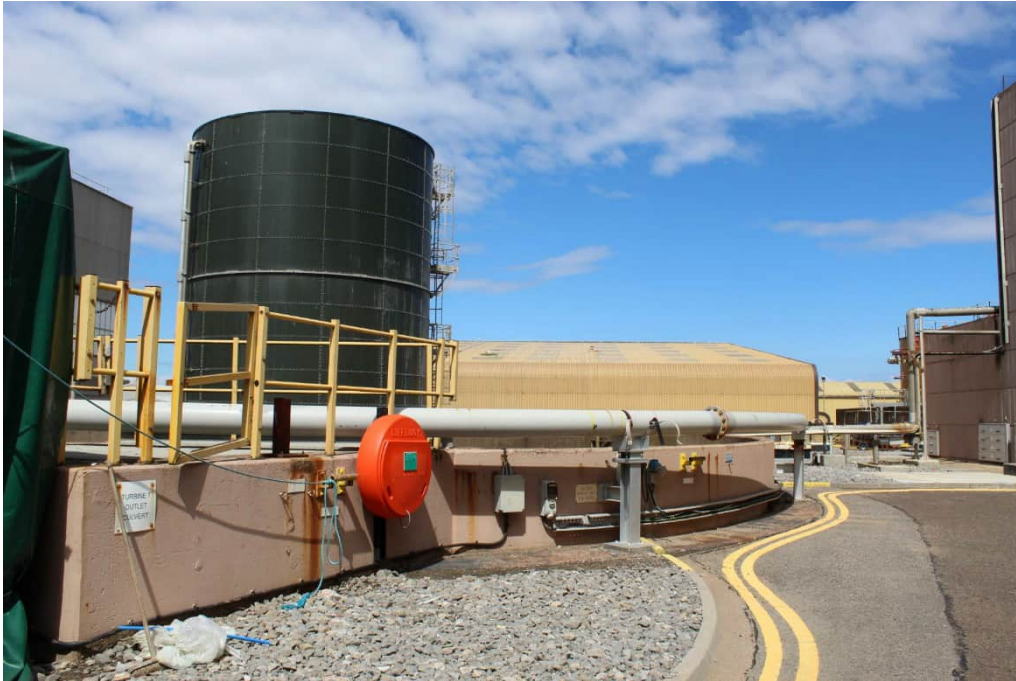
Plate 11. Original and modern ancillary buildings to the north of the turbine hall. View north.

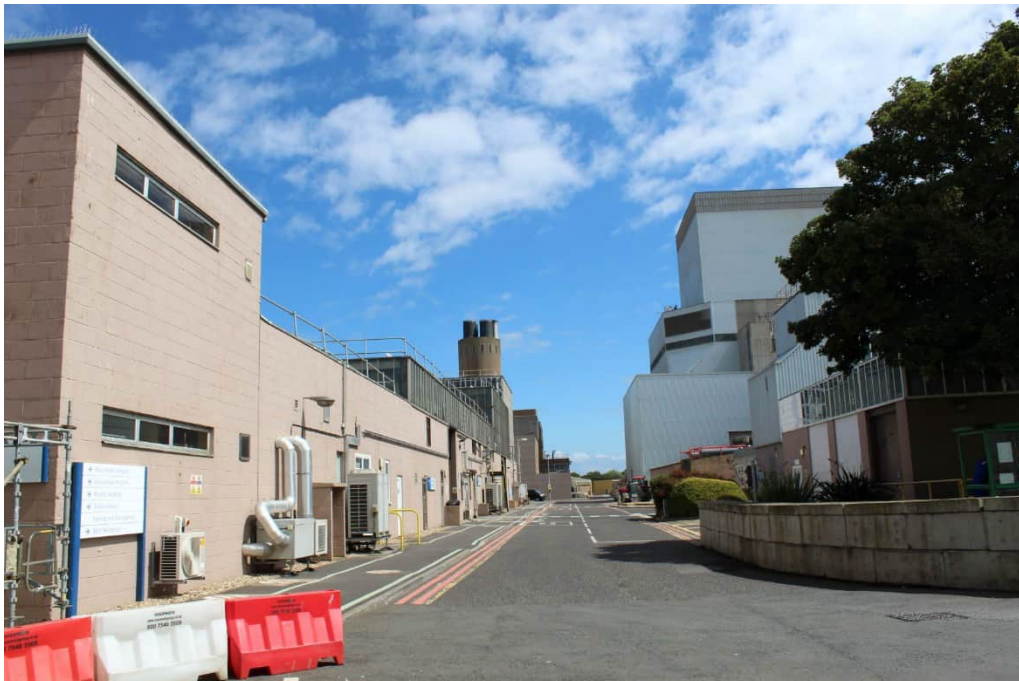
Plate 12. Original workshop buildings in the northern area of the Site. View east.

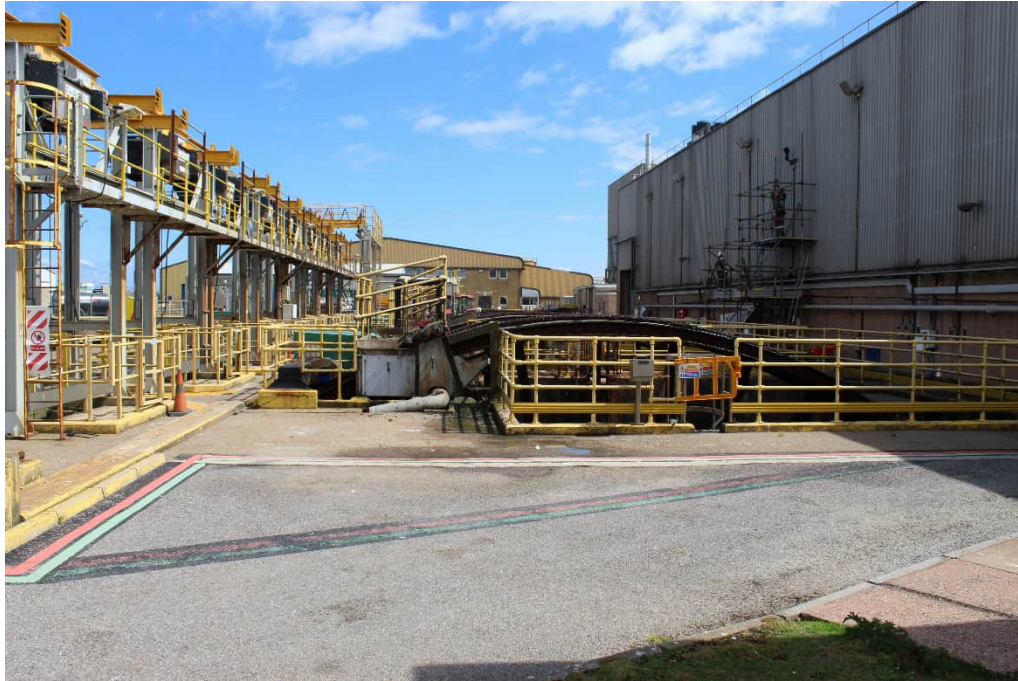
Plate 13. Pumphouse in the northern site area. View east.

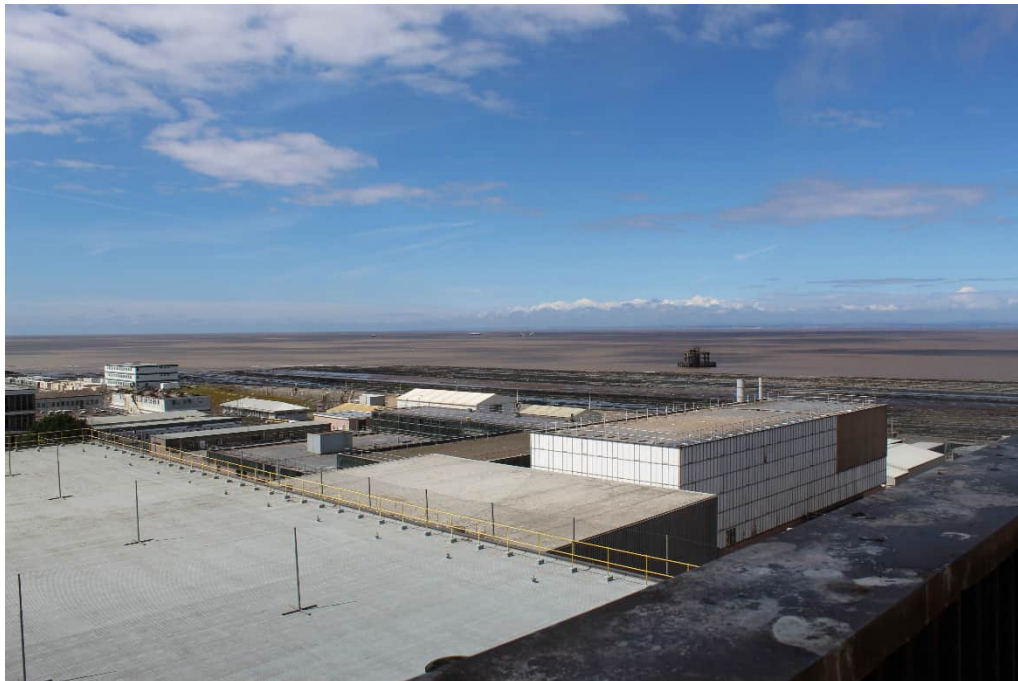
Plate 14. Water intake out to sea to the north. View north-east.

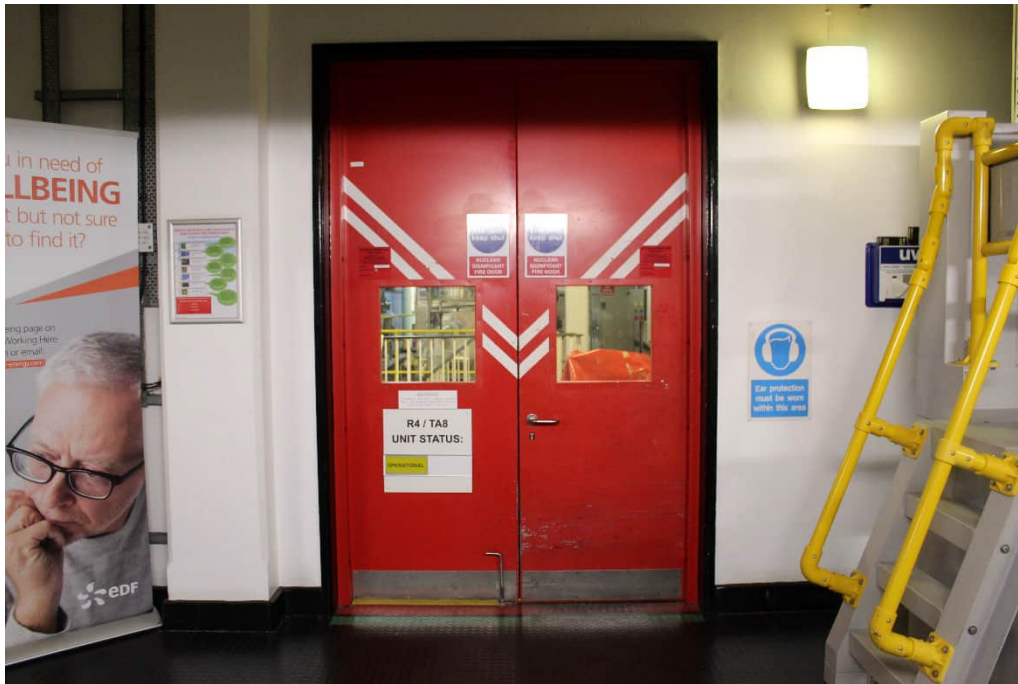
Plate 15. Interior entrance to Reactor 4 Unit.

The interior of the reactor buildings and turbine hall included original fixtures (**Plates 15-19**).

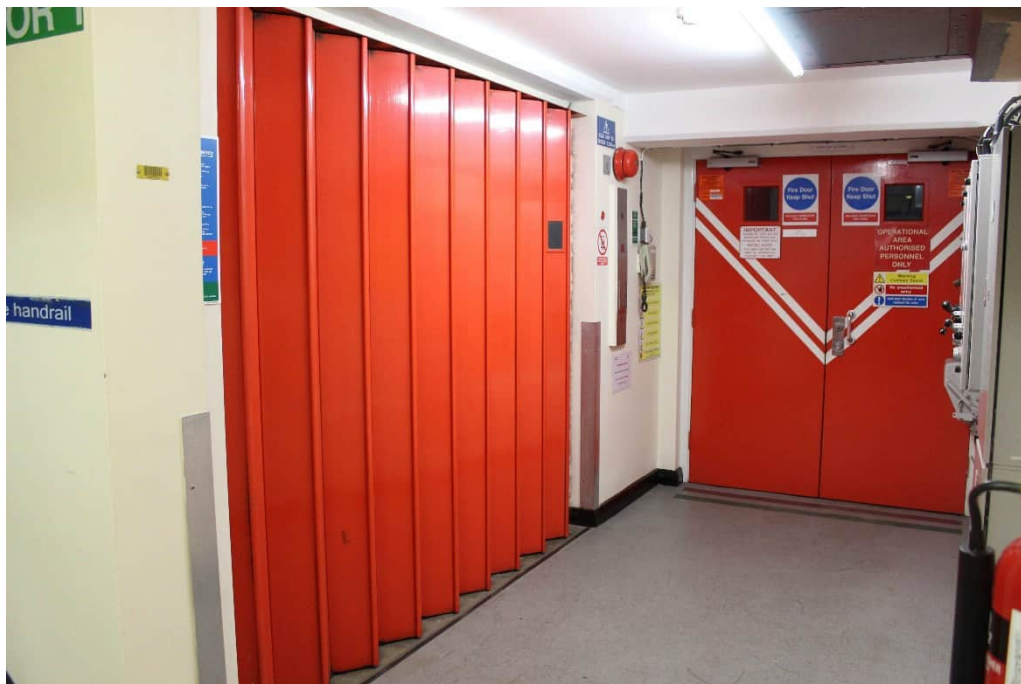
Plate 18. Reactor building interior features.
