ASSESSMENT REPORT			
Unique Document ID and Revision No:	ONR-OFD-AR-18-016 Revision 0	TRIM Ref:	2018/202683
Project:	Heysham 2 Reactor 7 2018 Periodic Shutdown		
Site:	Heysham 2		
Title:	Heysham 2 Reactor 7 2018 Periodic Shutdown: Structural Integrity Assessment of the Graphite Core Inspection Findings, including Consideration of EC 356531		
Nuclear Site Licence No:	588		
Licence Condition(s):	30, 28		
ONR Assessment Rating (Mandatory): <i>(Rating should be based on licensee's original safety case submission)</i>	GREEN		
COIN Service Order:	SVC4285368

**Heysham 2 Reactor 7 2018 Periodic Shutdown – Assessment of the results of the
Graphite Core Inspections**

Assessment Report ONR-OFD-AR-18-016
Revision 0
29 June 2018

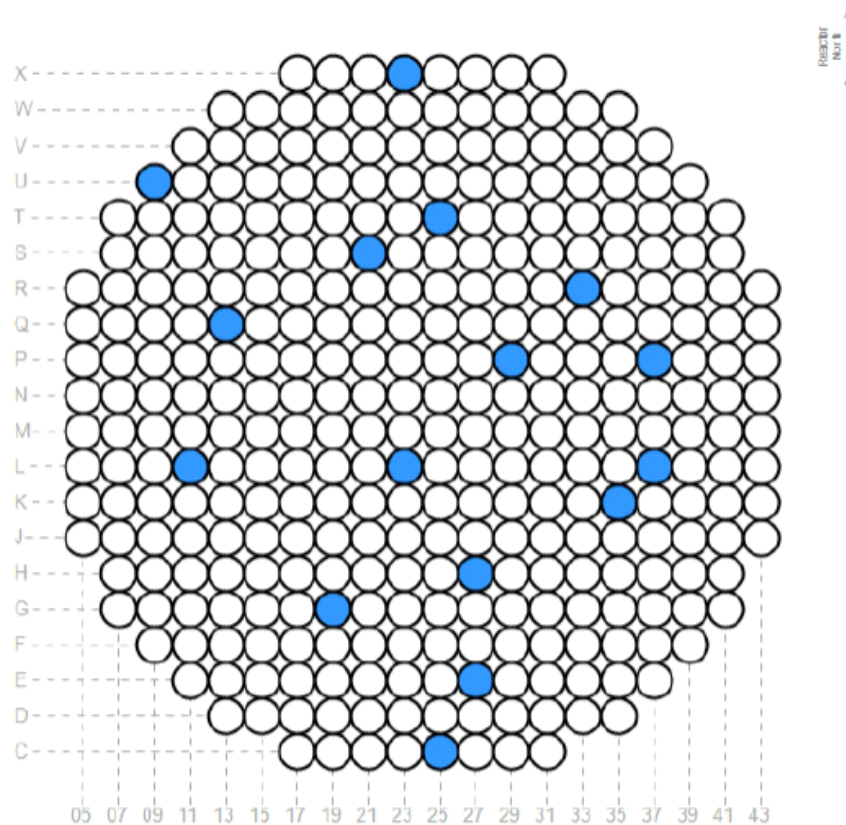
29. The sixteen fuel channels selected for inspection during the shutdown are listed below. Five of these fuel channels are re-inspections:

- Depressurised in air phase: X23, C25, L23, Q13, S21, H27, G19 and T25
- Depressurised CO₂ phase: P37, L11, K35, L37, R33, U09, P29 and E27
- Control rod channel: BC20

Figure 1: Core map showing the fuel channels inspected during 2018 HYB R7 periodic shutdown (Reference 15).

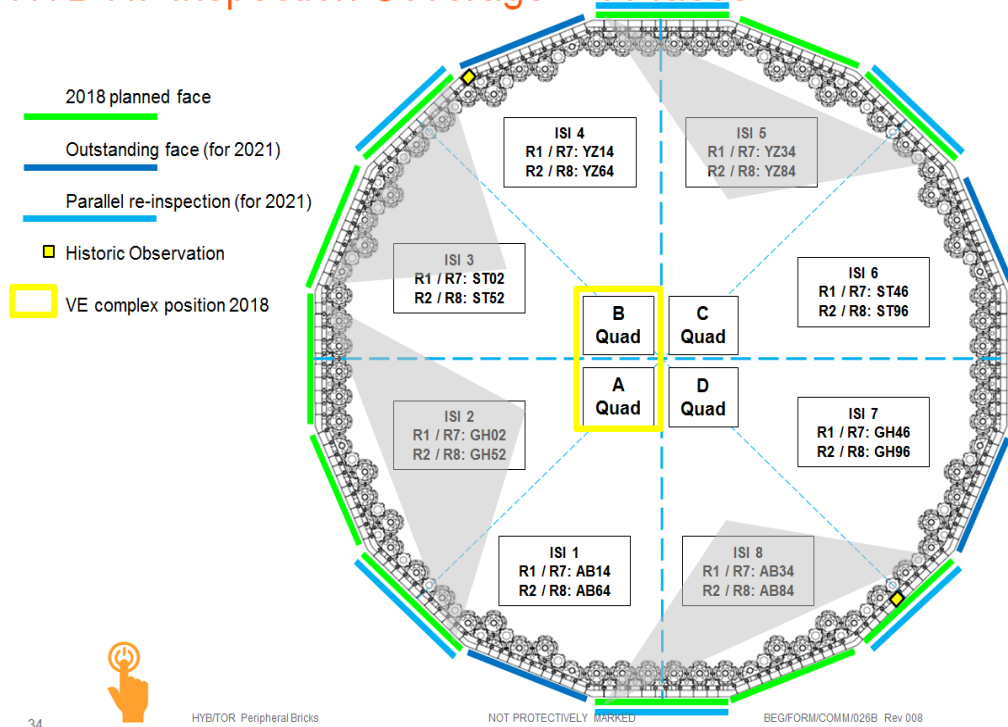
HYB R7 Inspection Coverage – 11 faces

- Minimum of nine faces will be adequate to establish consistency with other three reactors;
 - Three edge channels with NICIE2.
36. Figure 2 shows the eleven peripheral faces planned for inspection during the 2018 HYB R7 periodic shutdown and for future inspections.

Figure 2: Planned inspections of the peripheral bricks for the 2018 HYB R7 outage (Reference 21).
